Property Condition Assessment Report – Onoway Curling Club

Version:Final

March 2020

Prepared by
FCAPX Ltd.
Project No. 19064

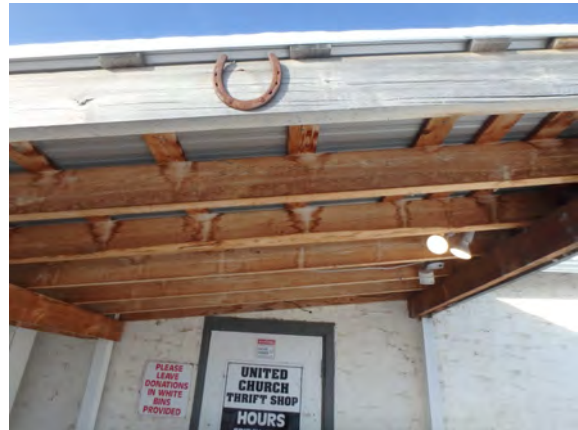
Onoway Curling Club - B1030

Water damage and cracks due to shrinkage were observed in the wood structures. Based on the foregoing, the component is recommended for replacement in the early stages of the evaluation period.

Recommendation #1 - Wood Canopy Structure	
Type	Failure Replacement
Year	2021
Cost	\$4,200.00

Subject to the findings and recommendation of the preceding investigation, conduct repairs to restore the condition / integrity of the wood canopy structures. A cost allowance to perform the repairs has been provided, however, the actual cost of the work will depend on the recommendations of the preceding investigation.

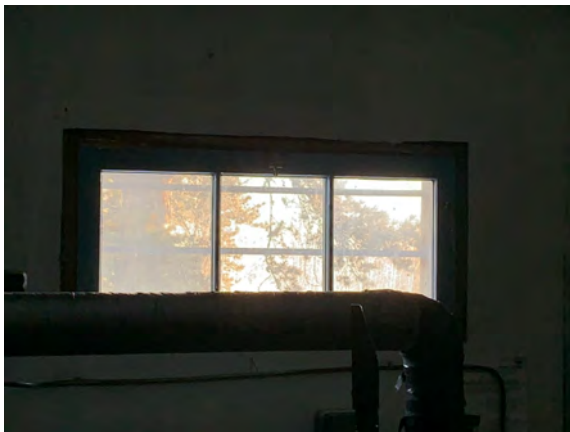
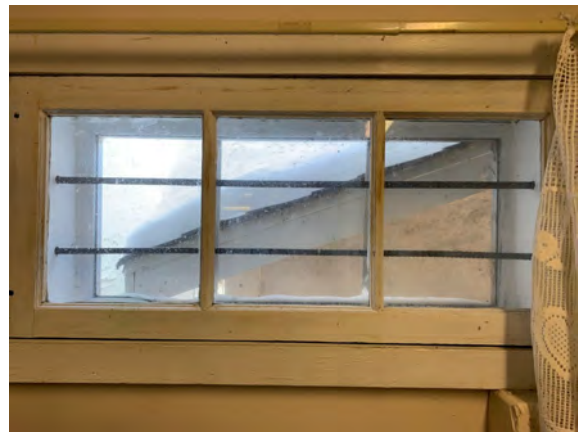
Onway Curling Club - B202001

The component has surpassed its typical expected useful life and is showing signs of wearing consistent with its age. Based on the foregoing, the component is recommended for replacement in the early stages of the evaluation period.

Recommendation #1 - Windows	
Type	Life Cycle Replacement
Year	2023
Cost	\$700.00

Replace Windows

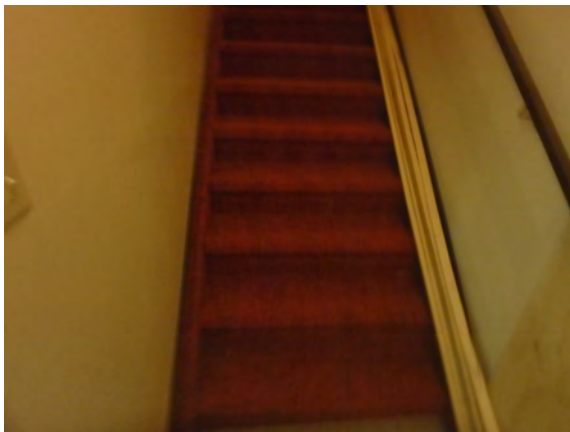
Onoway Curling Club - C202022

The component has surpassed its typical expected useful life and is showing signs of wearing consistent with its age. Based on the foregoing, the component is recommended for replacement in the early stages of the evaluation period.

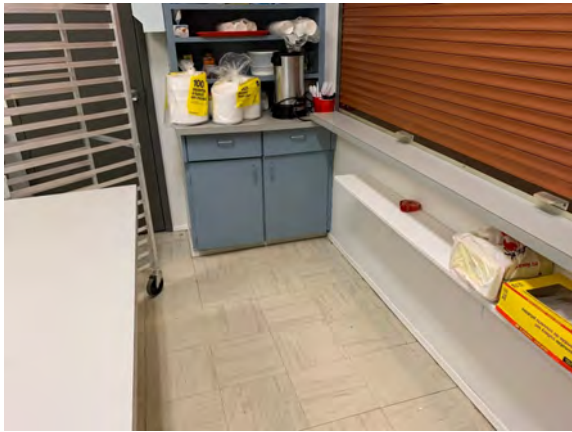
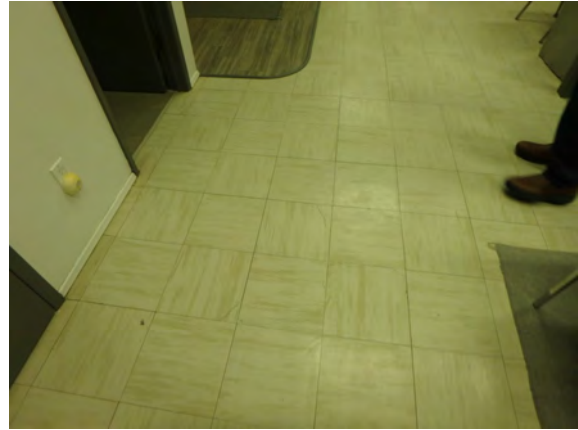
Onoway Curling Club - C302004

Localized deficiencies such as loose and cracked floor tiles in front of the washrooms on the lower level of the two-storey addition were observed and are anticipated to be addressed as part of routine maintenance activities.

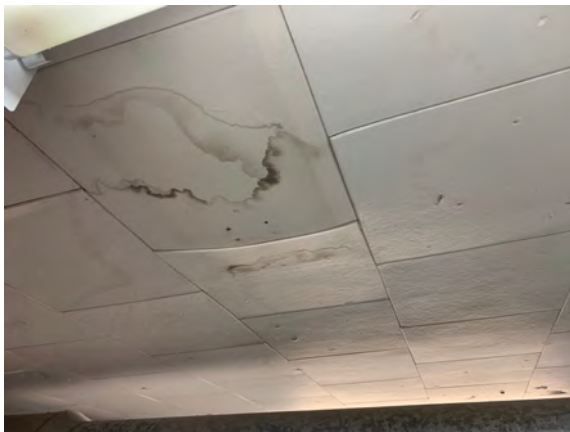
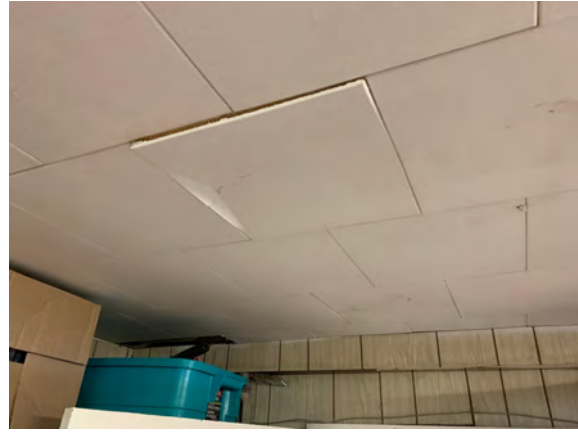
Onoway Curling Club - C303004

Localized staining and damage to the tiles were observed. The component has surpassed its typical expected useful life and is showing signs of wearing consistent with its age. Based on the foregoing, the component is recommended for replacement in the early stages of the evaluation period.

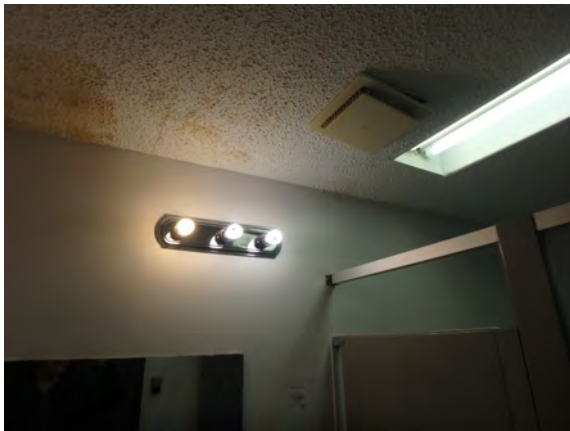
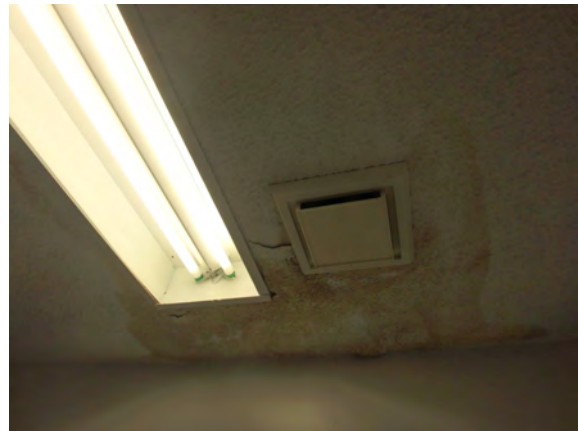
Onoway Curling Club - C303006

No significant deficiencies were observed or reported at the time of the field review. However, localized water staining on the ceiling was observed throughout the lower level, which was due to a past flood in the upper level washrooms. This is anticipated to be addressed as part of routine maintenance activities.

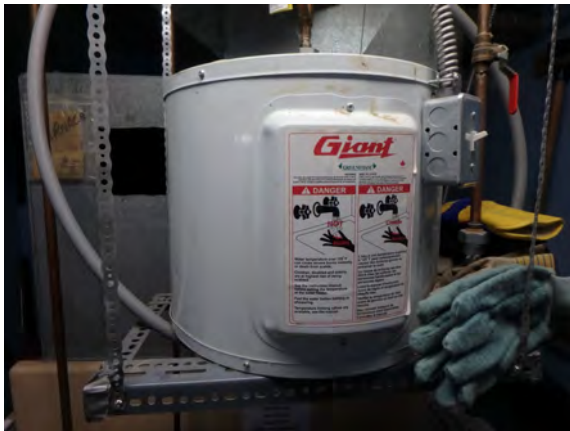
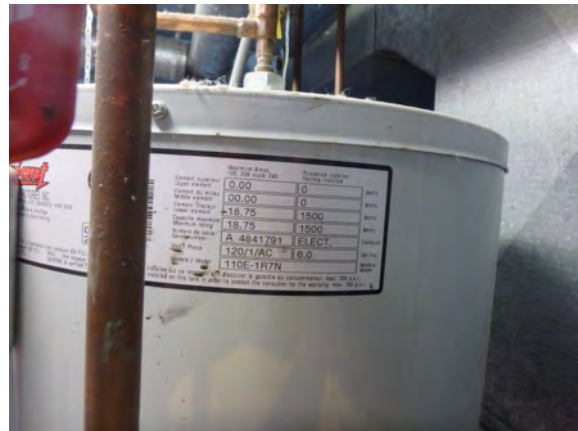
Onoway Curling Club - D202021

No significant deficiencies were observed or reported at the time of the field review. Nonetheless, the component has surpassed its expected useful life and is recommended for short-term replacement to mitigate the risk of sudden failure.

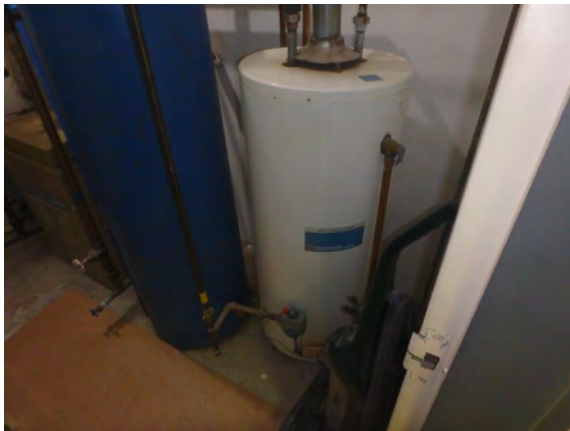
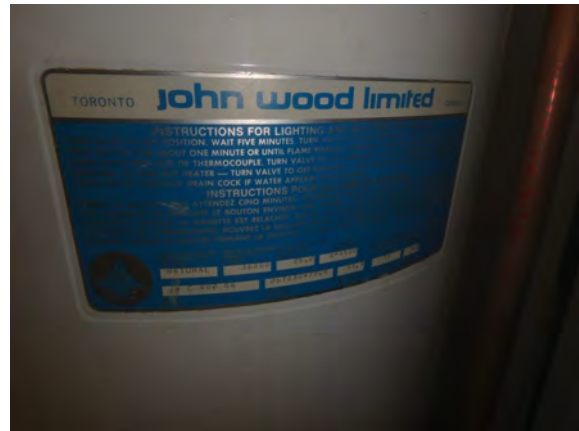
Onoway Curling Club - D202021

No significant deficiencies were observed or reported at the time of the field review. Nonetheless, the component has surpassed its expected useful life and is recommended for short-term replacement to mitigate the risk of sudden failure.

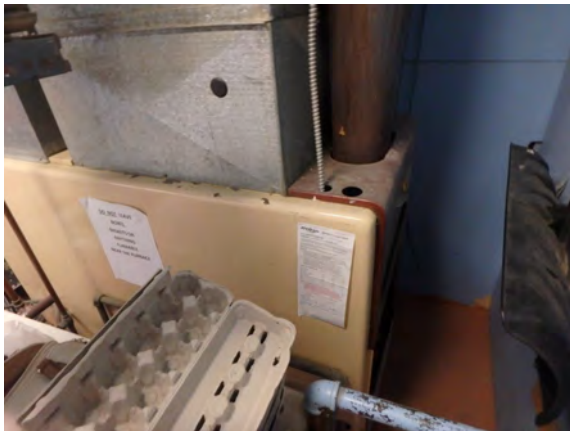
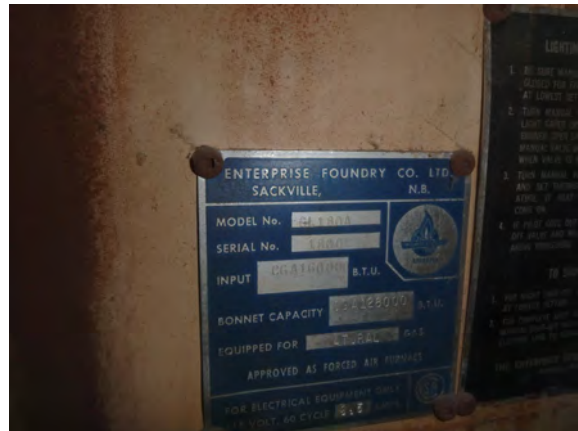
Onoway Curling Club - D302008

The component has surpassed its typical expected useful life and is showing signs of wearing consistent with its age. Replacement parts are difficult if at all possible to find and the furnace is inefficient. Replacement is recommended in the upcoming years.

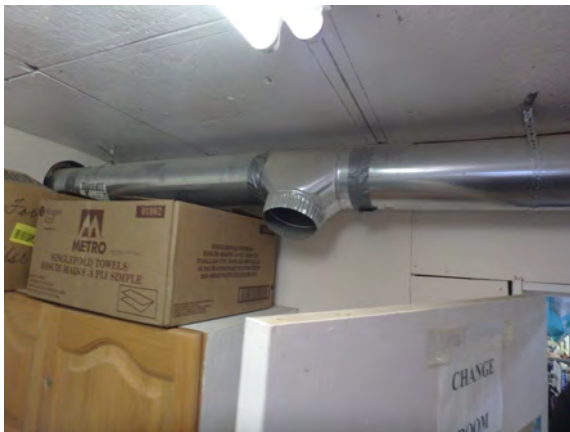
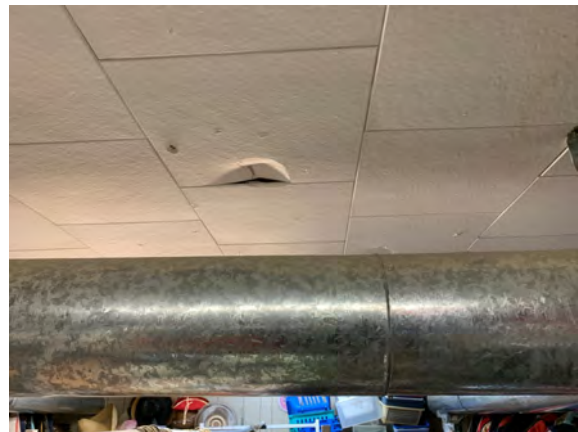
Onoway Curling Club - D304001

The component has surpassed its typical expected useful life and is showing signs of wearing consistent with its age. Based on the foregoing, the component is recommended for replacement in the early stages of the evaluation period.

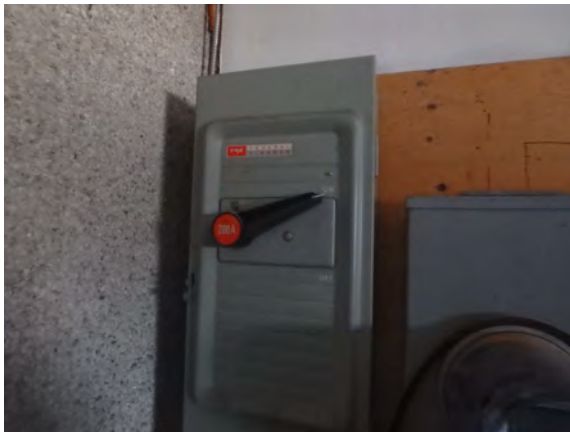
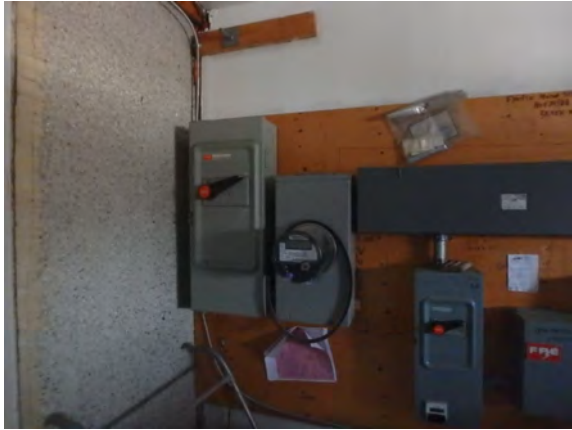
Onoway Curling Club - D501022

Localized corroded surfaces were observed on the element housing. The component has surpassed its typical expected useful life and is showing signs of wearing consistent with its age. Based on the foregoing, the component is recommended for replacement in the early stages of the evaluation period. The service should be re-evaluated with the replacement of the ice plant.

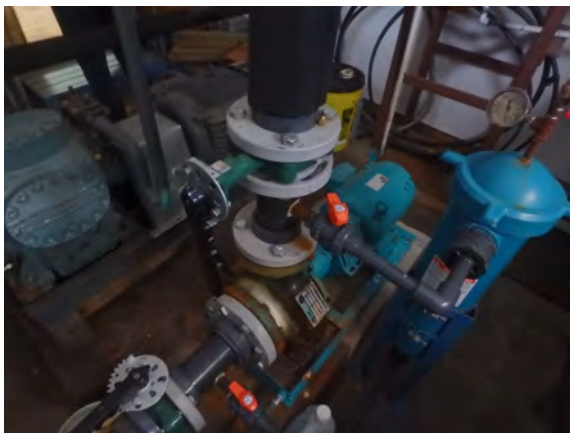
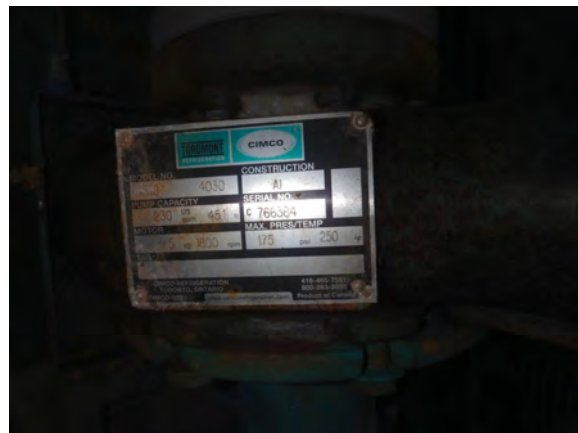
Onoway Curling Club - F104203

The component has surpassed its typical expected useful life and is showing signs of wearing consistent with its age. Based on the foregoing, the component is recommended for replacement in the early stages of the evaluation period. It is recommended the ice plant as a whole be replaced and relocated.
