Property Condition Assessment Report – Onoway Curling Club

Version:Final

March 2020

Prepared by
FCAPX Ltd.
Project No. 19064

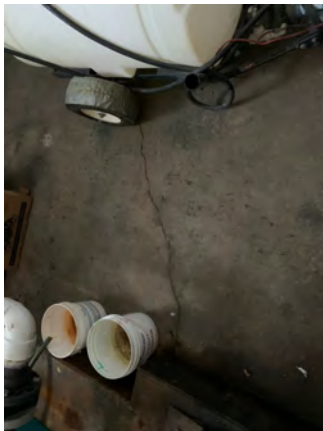
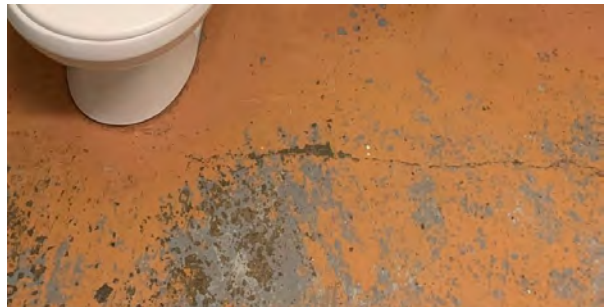
Onoway Curling Club - A1030

No significant deficiencies were observed or reported at the time of the assessment. However, localized cracks were observed in the ice plant and the thrift shop, and are anticipated to be monitored and/or repaired as part of routine maintenance activities.

Replace Slab on Grade

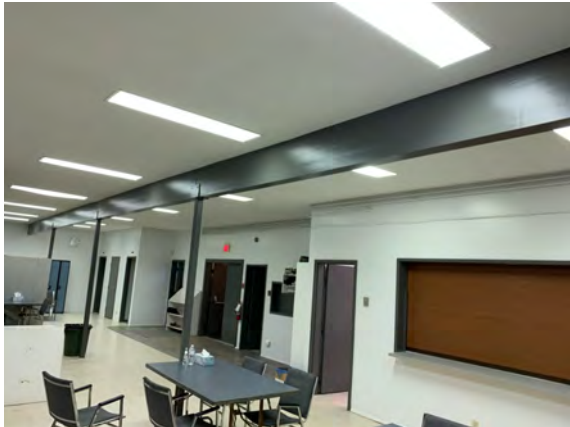
Onoway Curling Club - B1030

No significant deficiencies were observed or reported at the time of the field review. It should be noted that the review of the component was limited due to concealment by interior finishes at the time of the assessment.

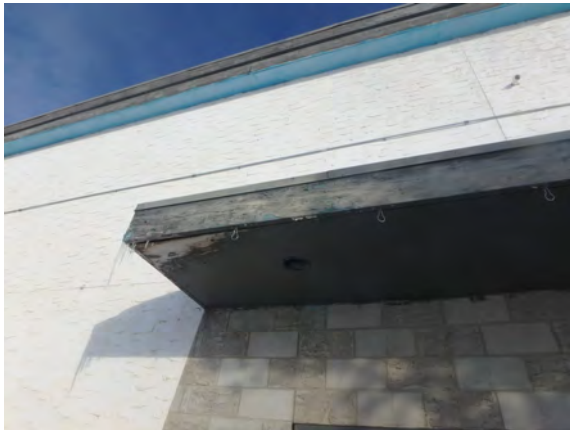
Onoway Curling Club - B1030

Water damage and cracks due to shrinkage were observed in the wood structures. Based on the foregoing, the component is recommended for replacement in the early stages of the evaluation period.

Subject to the findings and recommendation of the preceding investigation, conduct repairs to restore the condition / integrity of the wood canopy structures. A cost allowance to perform the repairs has been provided, however, the actual cost of the work will depend on the recommendations of the preceding investigation.

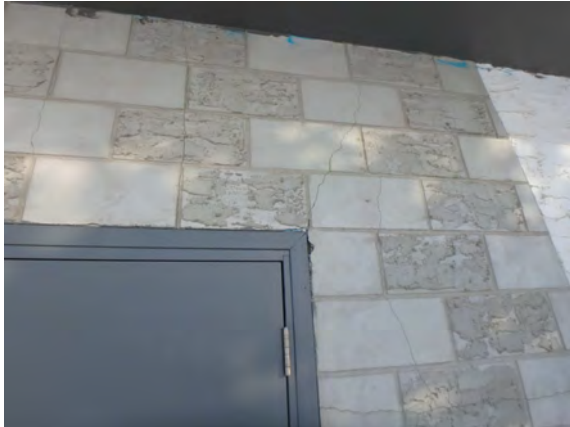
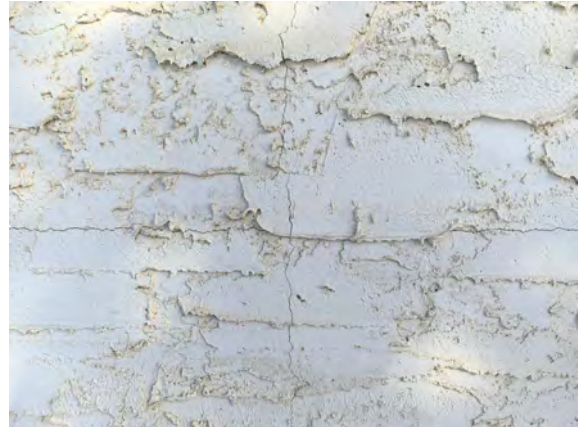
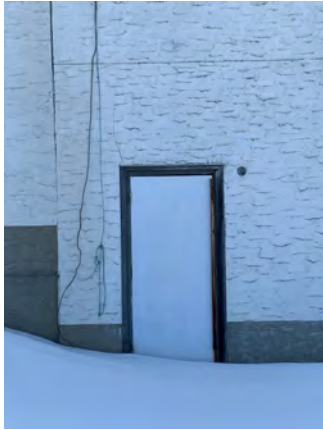
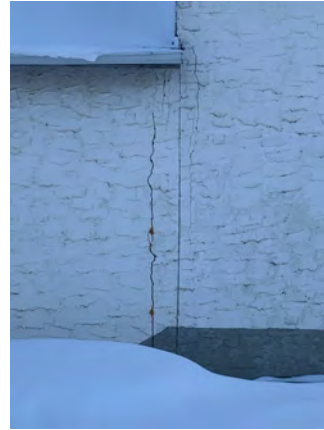
Onoway Curling Club - B201023

Hairline cracks were observed on most stucco-clad wall surfaces, primarily above wall openings and between adjoining building sections. Weathering of the wood fascia around the perimeter of the building was also observed, which is anticipated to be addressed as part of routine maintenance activities.

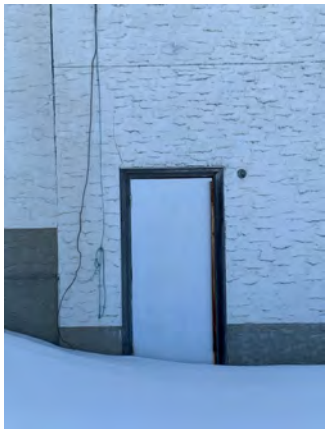
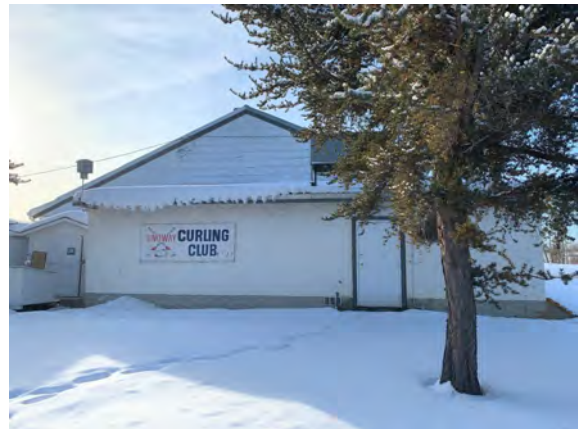
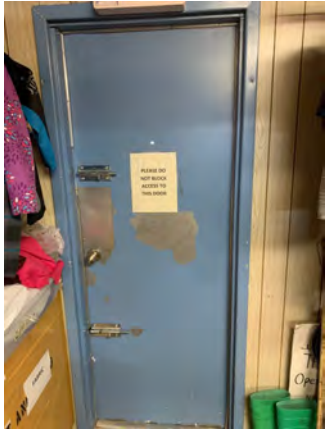
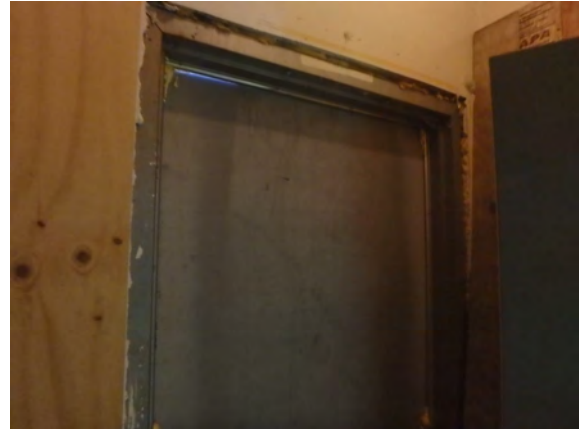
Onoway Curling Club - B203002

No significant deficiencies were observed or reported at the time of the assessment. However, localized deficiencies such as chipped paint, corrosion and absence of sealant around the door flashing were observed and are anticipated to be addressed as part of routine maintenance activities. It is recommended that the side-bolt hardware on the emergency exit door inside the thrift shop be removed, since the door is intended for use as means of emergency egress.

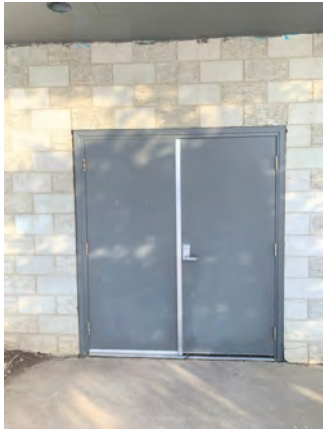
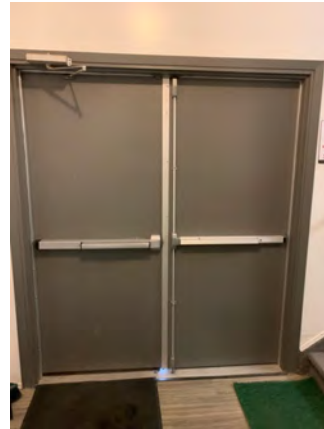
Onoway Curling Club - B203003

The component has exceeded its typical useful life, although its remaining useful life has been extended to a later year based on the absence of significant observed or reported deficiencies. However, localized corrosion was observed and is anticipated to be addressed as part of routine maintenance activities.

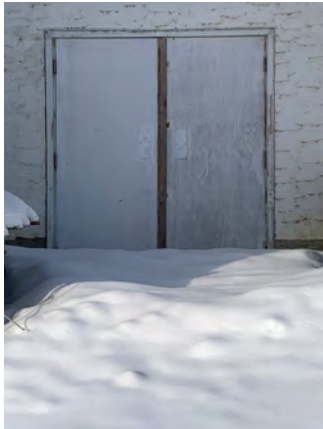
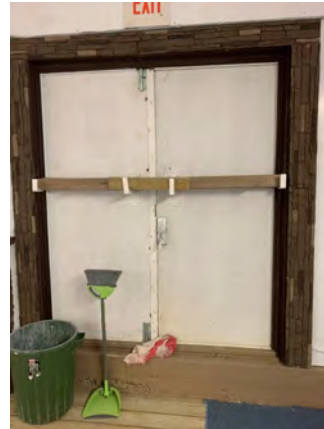
Onoway Curling Club - B203003

The component has surpassed its typical expected useful life and is showing signs of wearing consistent with its age. Based on the foregoing, the component is recommended for replacement in the early stages of the evaluation period.

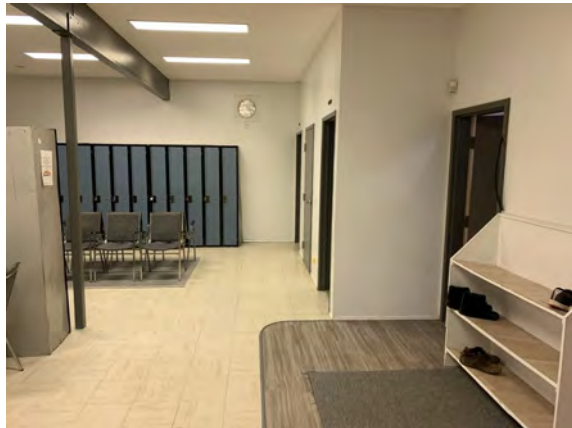
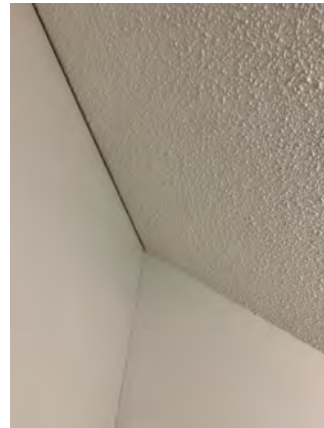
Onoway Curling Club - C101001

No significant deficiencies were observed or reported at the time of the assessment. However, localized deficiencies such as separation of wall and roof joint in the lower level storage room was observed and is anticipated to be addressed as part of routine maintenance activities.

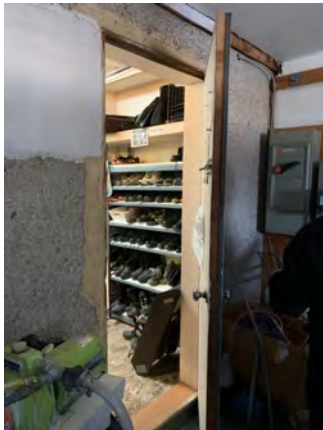
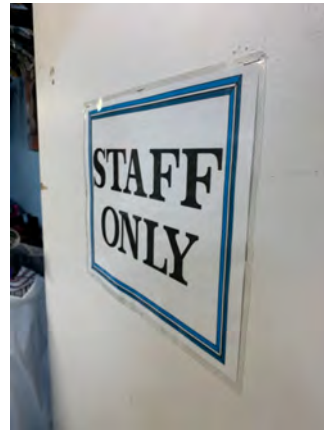
Onoway Curling Club - C101002

No significant deficiencies were observed or reported at the time of the field review. The component has exceeded its typical useful life, although its remaining useful life has been extended to a later year based on the absence of significant observed or reported deficiencies.

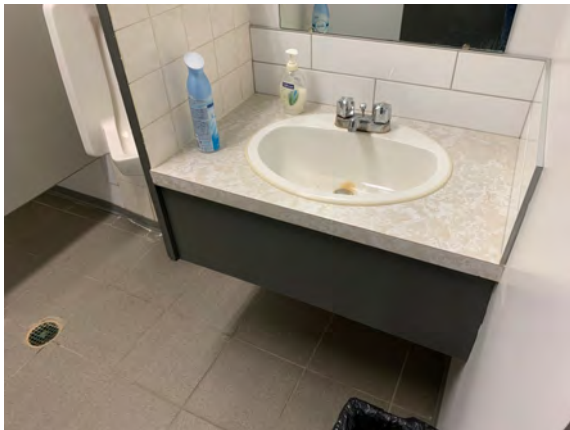
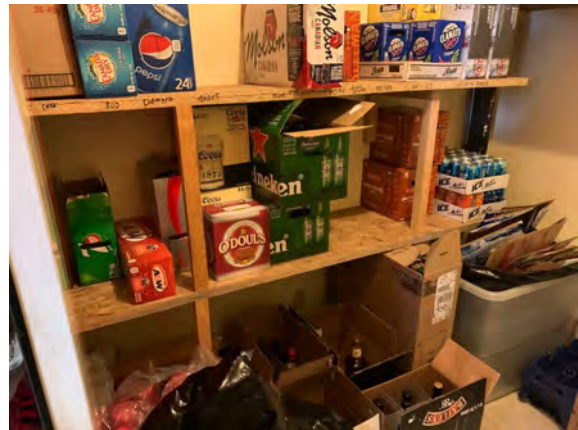
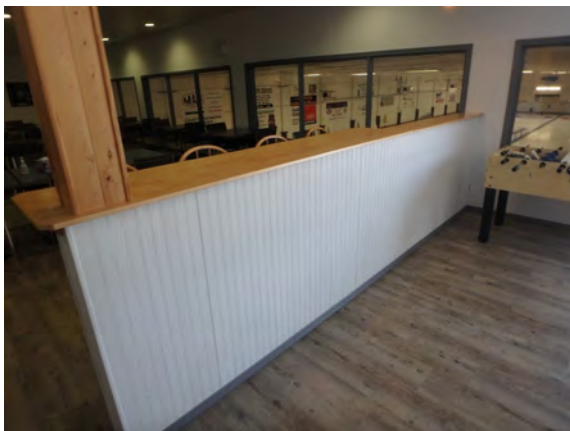
No significant deficiencies were observed or reported at the time of the field review.

Recommendation #1 - Cabinets - Millwork	
Type	Life Cycle Replacement
Year	2042
Cost	\$2,500.00

Replace Cabinets - Millwork

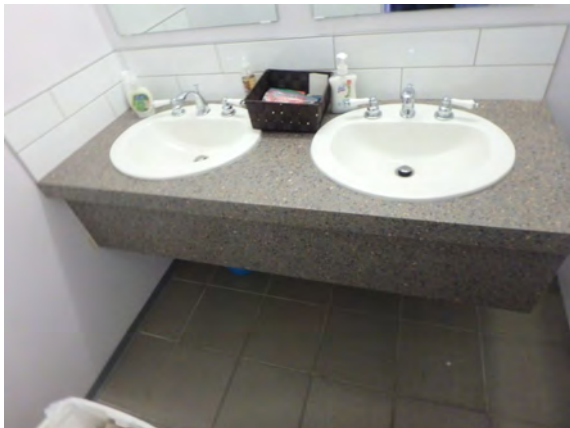
Onoway Curling Club - C103009

No significant deficiencies were observed or reported at the time of the field review.

Recommendation #1 - Cabinets - Millwork	
Type	Life Cycle Replacement
Year	2048
Cost	\$1,500.00

Replace Cabinets - Millwork

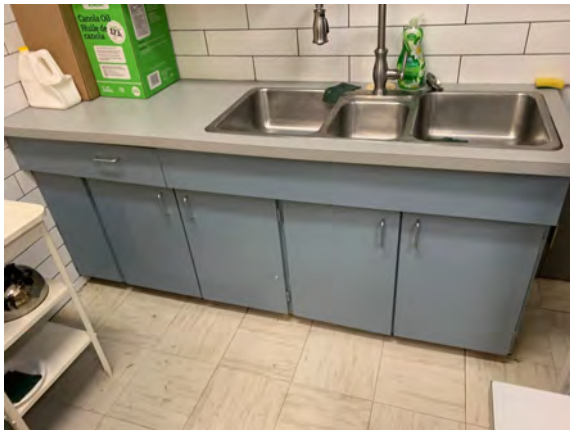
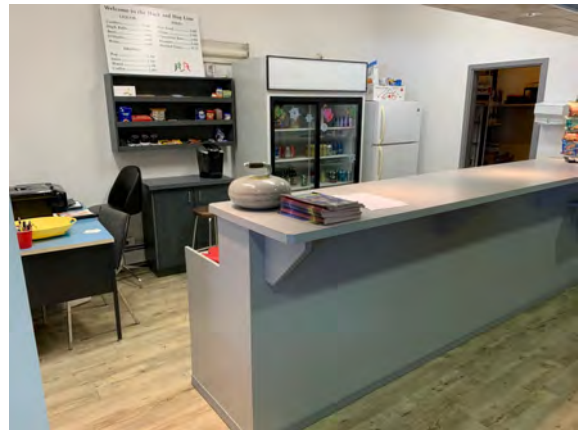
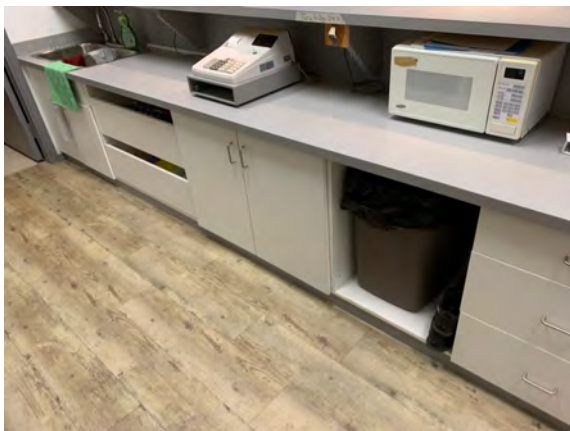
Onoway Curling Club - C103010

No significant deficiencies were observed or reported at the time of the field review.

Recommendation #1 - Cabinets - Kitchen	
Type	Life Cycle Replacement
Year	2042
Cost	\$12,000.00

Replace Cabinets - Kitchen

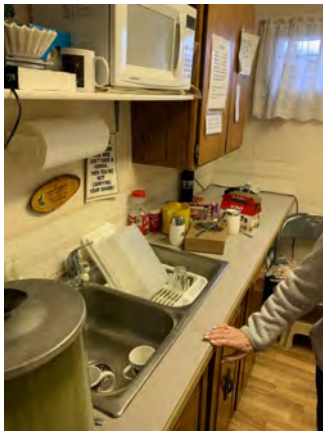
Onoway Curling Club - C103010

No significant deficiencies were observed or reported at the time of the field review.

Recommendation #1 - Cabinets - Kitchen	
Type	Life Cycle Replacement
Year	2042
Cost	\$6,000.00

Replace Cabinets - Kitchen

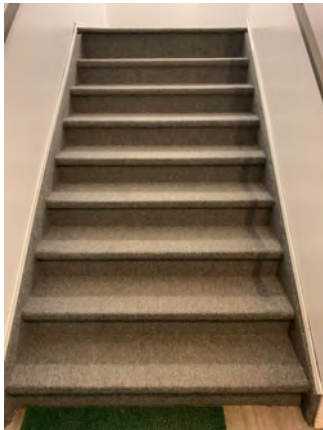
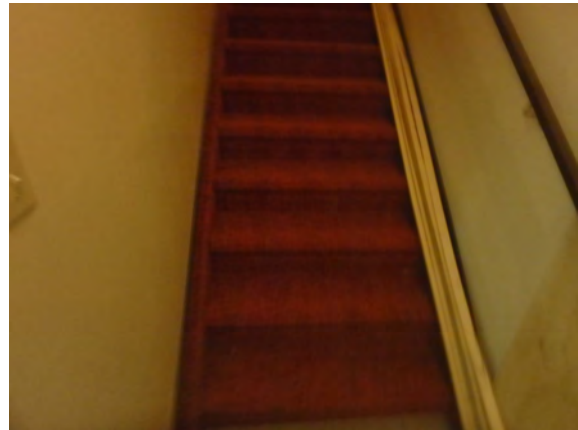
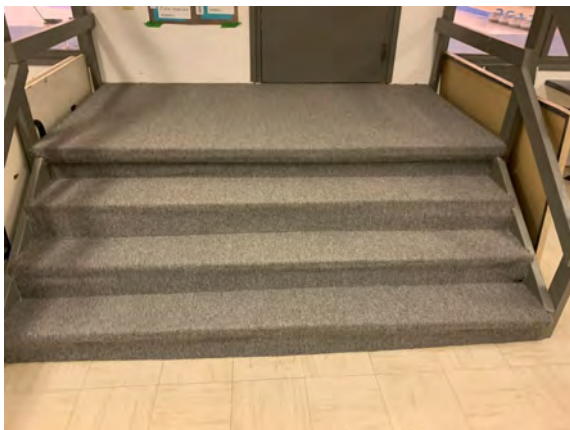
Onoway Curling Club - C201001

No significant deficiencies were observed or reported at the time of the field review.

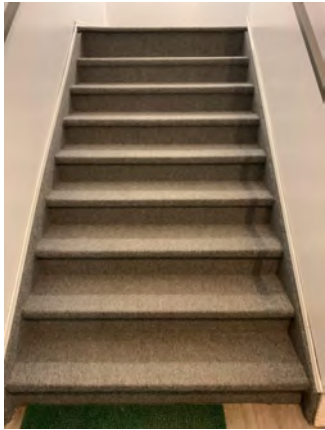
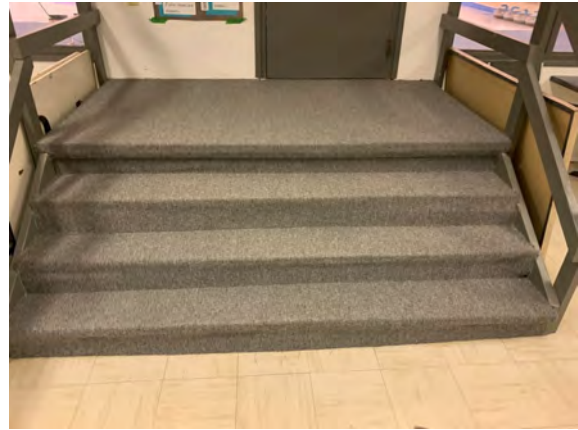
Onoway Curling Club - C202022

No significant deficiencies were observed or reported at the time of the field review.

Recommendation #1 - Carpet	
Type	Life Cycle Replacement
Year	2032
Cost	\$2,520.00

Replace Carpet

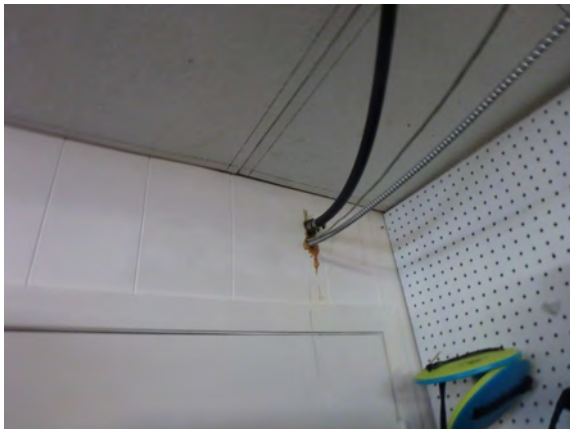
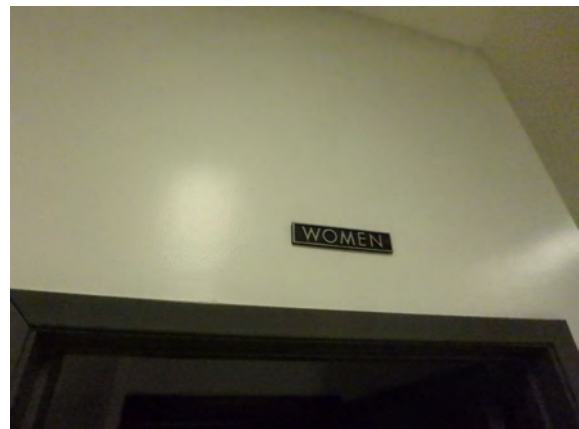
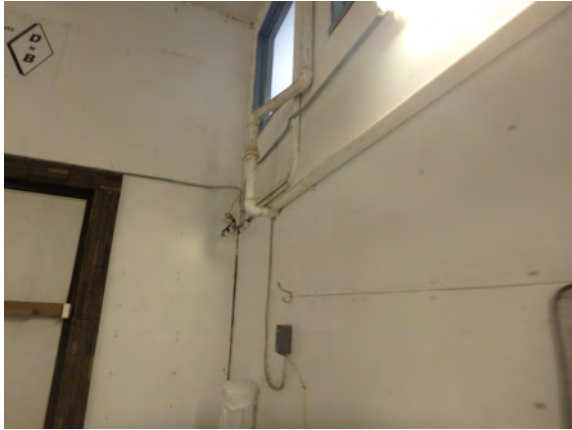
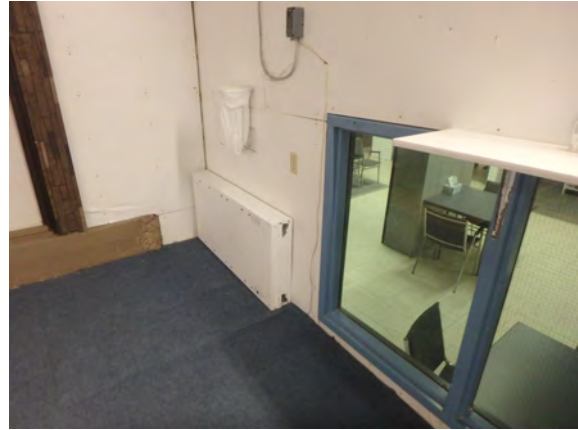
Onoway Curling Club - C301005

No significant deficiencies were observed or reported at the time of the field review. The component is nearing the end of its typical useful life, although its remaining useful life has been extended to a later year based on the absence of significant observed or reported deficiencies.

Recommendation #1 - Painted Wall Covering	
Type	Life Cycle Replacement
Year	2026
Cost	\$53,800.00

Replace Painted Wall Covering

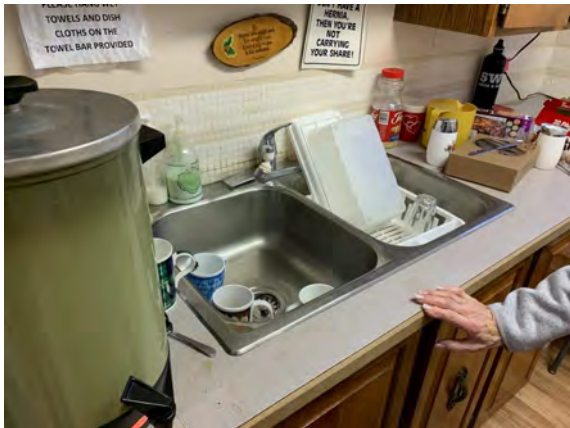
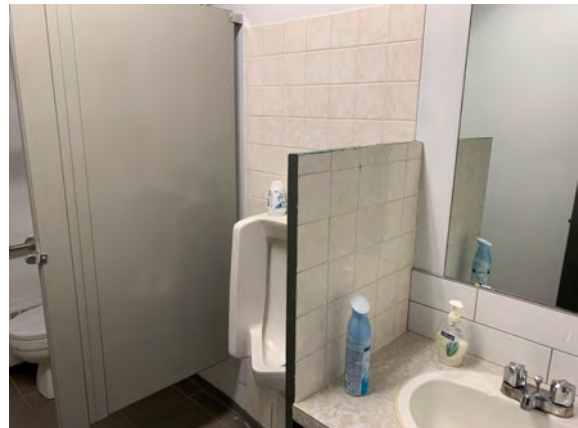
Onoway Curling Club - C302001

No significant deficiencies were observed or reported at the time of the field review.

Recommendation #1 - Ceramic Tile	
Type	Life Cycle Replacement
Year	2042
Cost	\$1,500.00

Replace Ceramic Tile

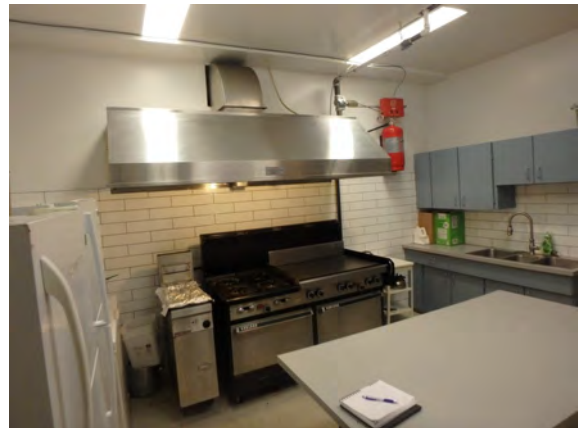
Onoway Curling Club - C301023

No significant deficiencies were observed or reported at the time of the field review.

Recommendation #1 - Ceramic Tile	
Type	Life Cycle Replacement
Year	2048
Cost	\$2,250.00

Replace Ceramic Tile

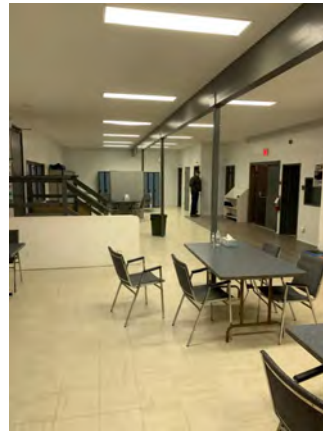
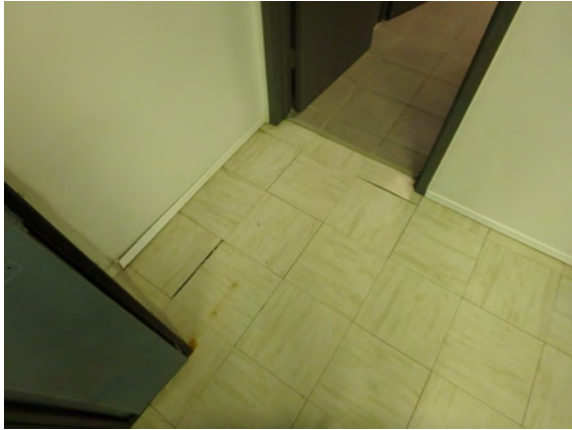
Onoway Curling Club - C302004

Localized deficiencies such as loose and cracked floor tiles in front of the washrooms on the lower level of the two-storey addition were observed and are anticipated to be addressed as part of routine maintenance activities.

Recommendation #1 - Vinyl Tile	
Type	Life Cycle Replacement
Year	2032
Cost	\$12,000.00

Replace Vinyl Tile

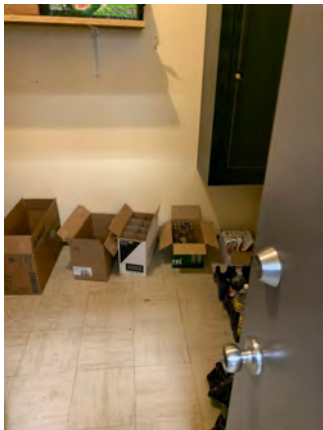
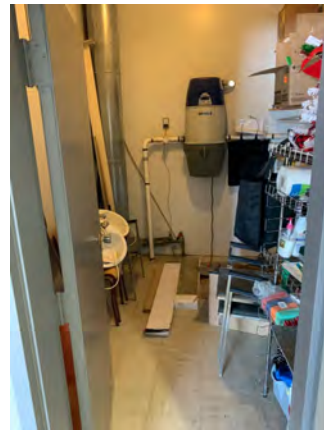
Onoway Curling Club - C302004

No significant deficiencies were observed or reported at the time of the field review.

Recommendation #1 - Vinyl Tile	
Type	Life Cycle Replacement
Year	2032
Cost	\$2,400.00

Replace Vinyl Tile

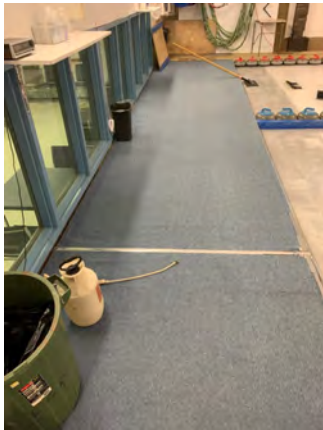
Onoway Curling Club - C302005

No significant deficiencies were observed or reported at the time of the field review. The component is nearing the end of its typical useful life, although its remaining useful life has been extended to a later year based on the absence of significant observed or reported deficiencies.

Recommendation #1 - Carpet	
Type	Life Cycle Replacement
Year	2026
Cost	\$3,000.00

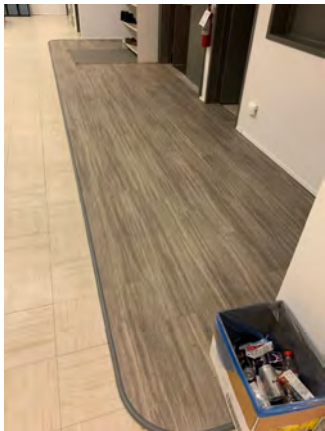
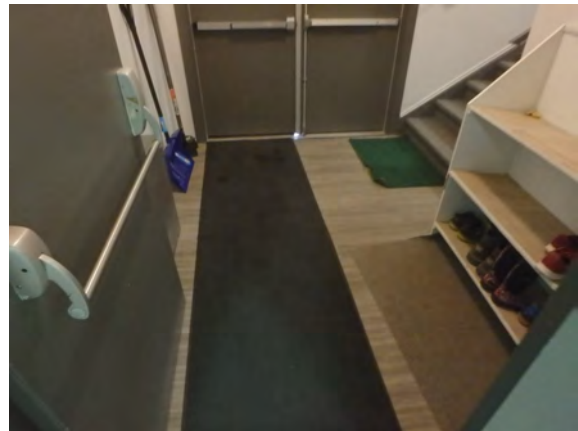
Onoway Curling Club - C302006

No significant deficiencies were observed or reported at the time of the field review.

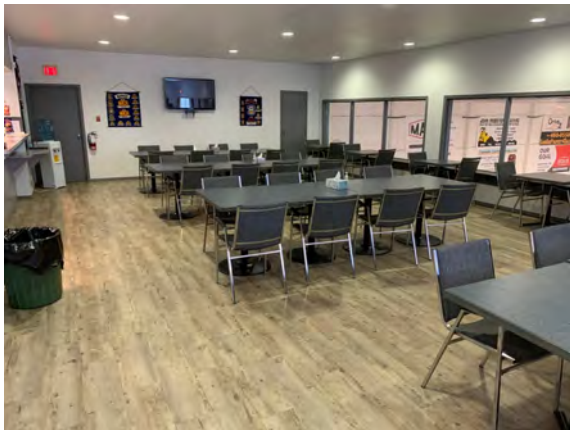
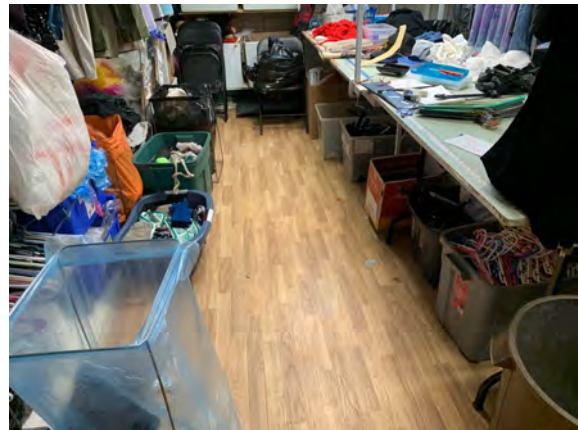
Onoway Curling Club - C302006

No significant deficiencies were observed or reported at the time of the field review.

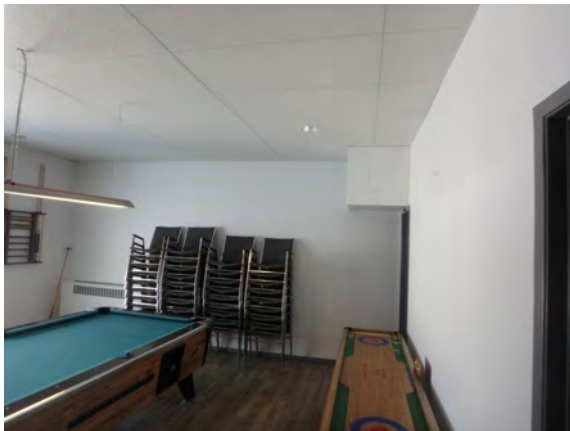
Onoway Curling Club - C303007

No significant deficiencies were observed or reported at the time of the field review.

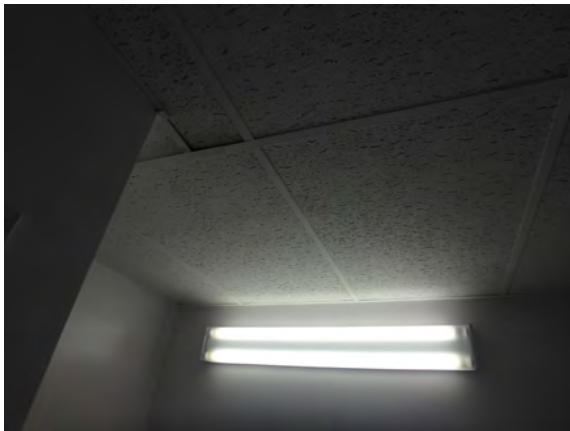
Onoway Curling Club - C303007

No significant deficiencies were observed or reported at the time of the field review.

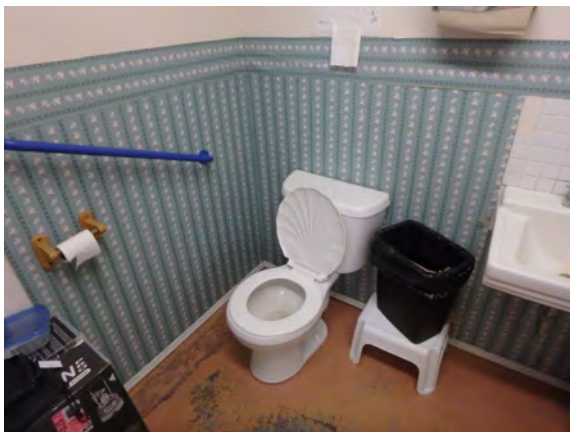
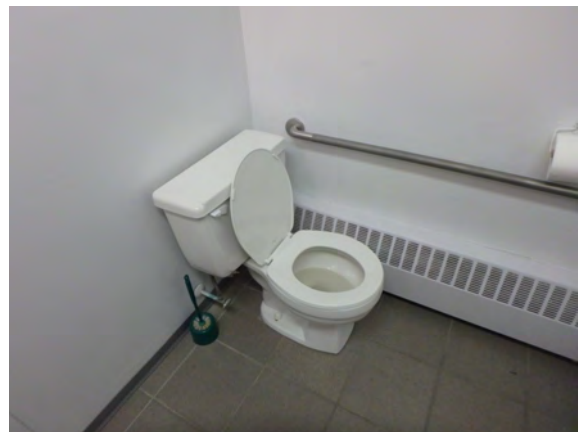
Onoway Curling Club - D201001

No significant deficiencies were observed or reported at the time of the field review.

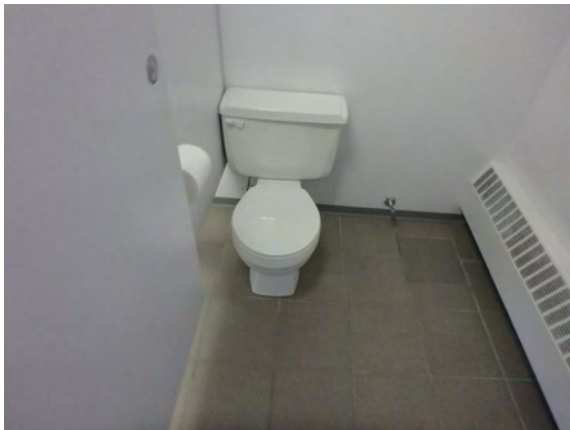
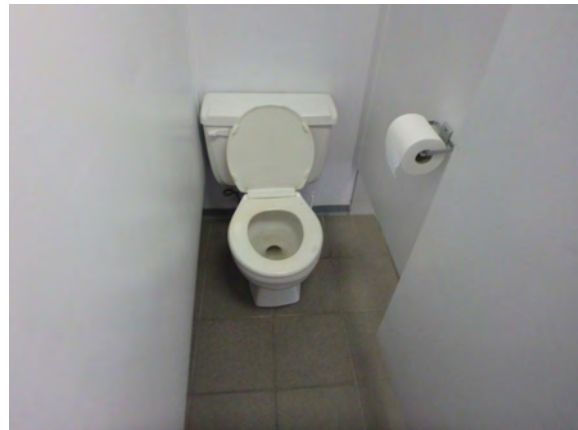
Onoway Curling Club - D201001

No significant deficiencies were observed or reported at the time of the field review.

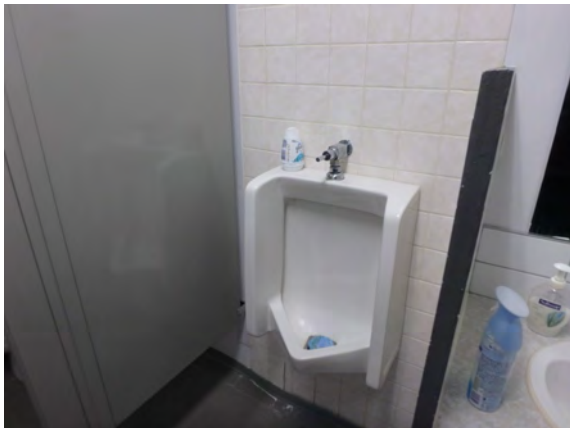
Onoway Curling Club - D201002

No significant deficiencies were observed or reported at the time of the field review.

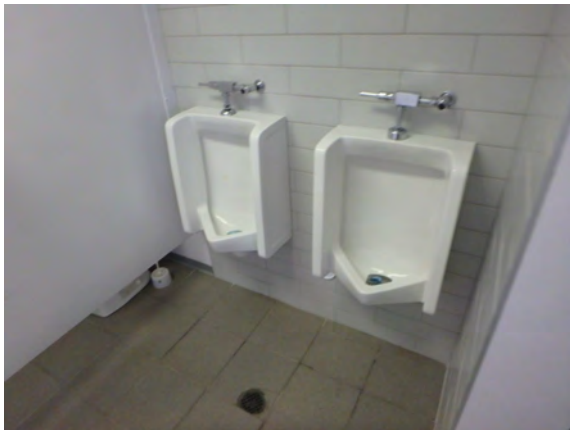
Onoway Curling Club - D201002

No significant deficiencies were observed or reported at the time of the field review.

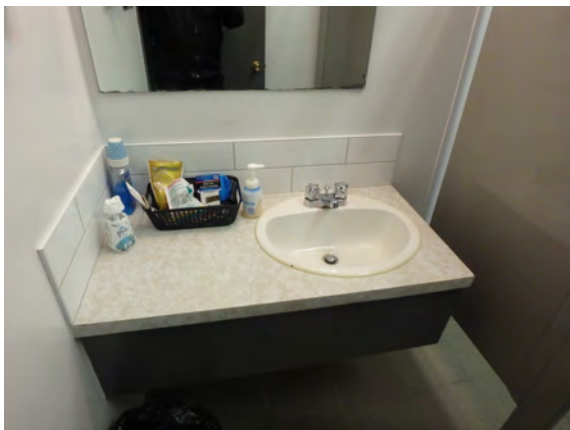
Onoway Curling Club - D201003

No significant deficiencies were observed or reported at the time of the field review.

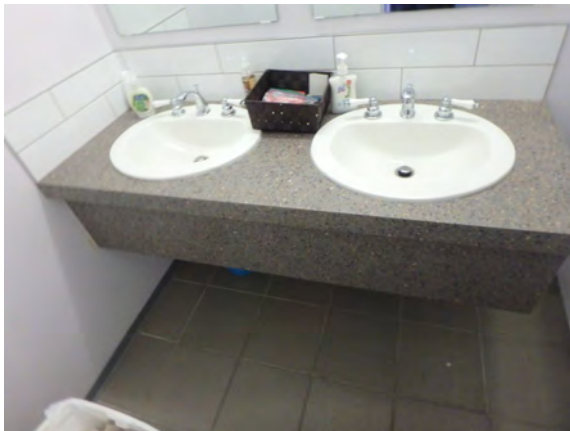
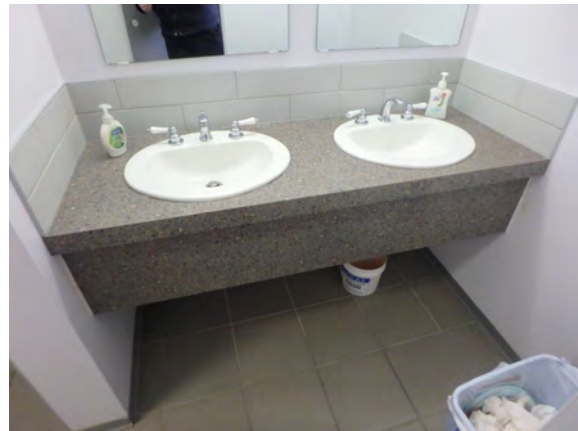
Onoway Curling Club - D201003

No significant deficiencies were observed or reported at the time of the field review.

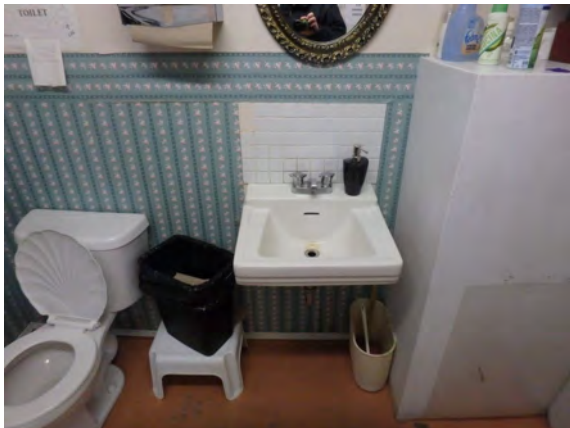
Onoway Curling Club - D201003

No significant deficiencies were observed or reported at the time of the field review therefore replacement has been deferred.

Recommendation #1 - Lavatories	
Type	Life Cycle Replacement
Year	2026
Cost	\$1,000.00

Replace Lavatories

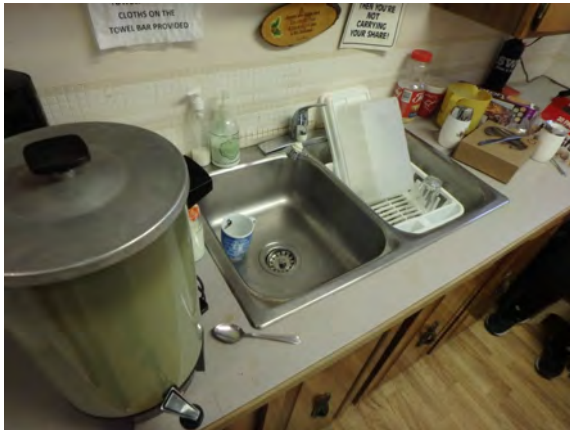
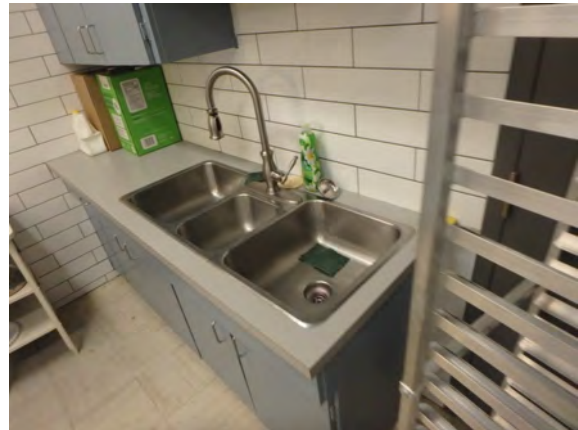
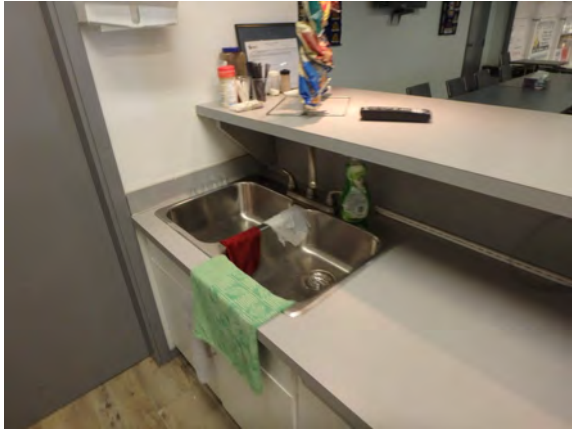
Onoway Curling Club - D201004

Double basin stainless steel sinks are provided for the kitchens in both the thrift shop and the upper level of the two-storey addition. A triple basin sink is provided for the kitchen in the lower level of the two-storey addition.

No significant deficiencies were observed or reported at the time of the field review.

Recommendation #1 - Sinks	
Type	Life Cycle Replacement
Year	2047
Cost	\$4,500.00

Replace Sinks

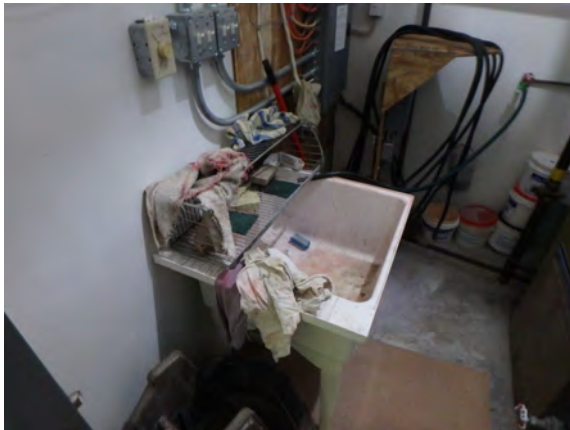
Onoway Curling Club - D201024

No significant deficiencies were observed or reported at the time of the field review. The component has exceeded its typical useful life, although its remaining useful life has been extended to a later year based on the absence of significant observed or reported deficiencies.

Recommendation #1 - Custodial Sinks	
Type	Life Cycle Replacement
Year	2026
Cost	\$500.00

Replace Custodial Sinks

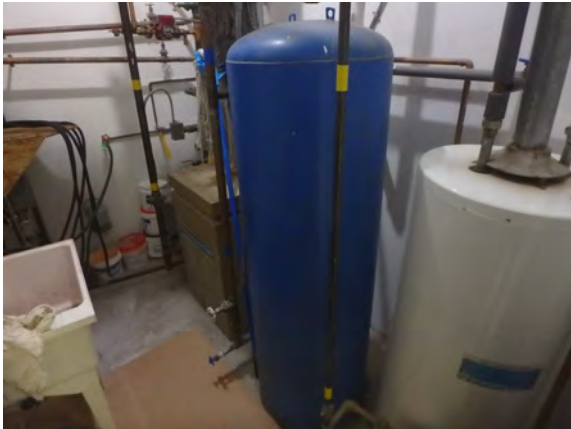
Onoway Curling Club - D202001

No significant deficiencies were observed or reported at the time of the field review. It should be noted that the review of the component was limited due to concealment by interior finishes. Replacement has been deferred.

Recommendation #1 - Domestic Water Pipes and Fittings	
Type	Life Cycle Replacement
Year	2026
Cost	\$16,800.00

Replace Domestic Water Pipes and Fittings

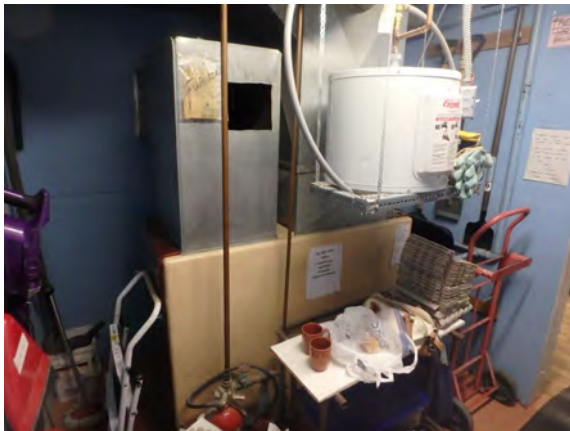
Onoway Curling Club - D202001

No significant deficiencies were observed or reported at the time of the field review. It should be noted that the review of the component was limited due to concealment by interior finishes. Replacement has been deferred.

Recommendation #1 - Domestic Water Pipes and Fittings	
Type	Life Cycle Replacement
Year	2026
Cost	\$8,800.00

Replace Domestic Water Pipes and Fittings

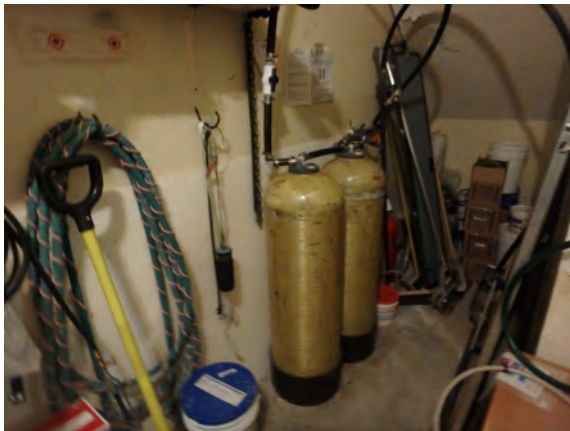
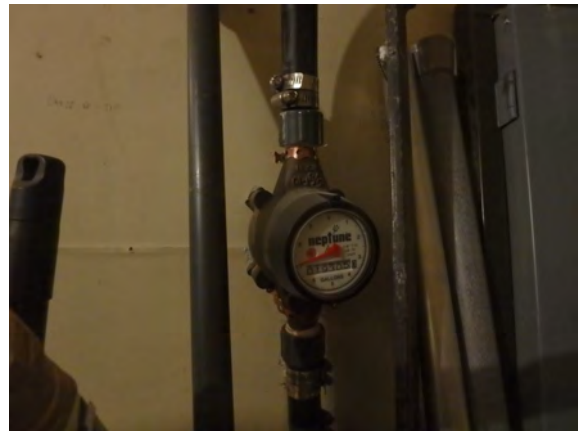
Onoway Curling Club - D202004

No significant deficiencies were observed or reported at the time of the field review.

Recommendation #1 - Domestic Water Equipment - Treatment Systems	
Type	Life Cycle Replacement
Year	2032
Cost	\$6,000.00

Replace Domestic Water Equipment - Treatment Systems

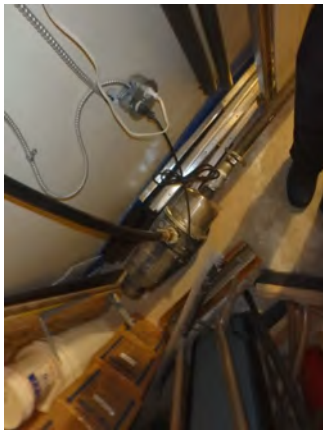
Onoway Curling Club - D202024

No significant deficiencies were observed or reported at the time of the field review.

Recommendation #1 - Domestic Water Pump	
Type	Life Cycle Replacement
Year	2032
Cost	\$1,500.00

Replace Domestic Water Pump

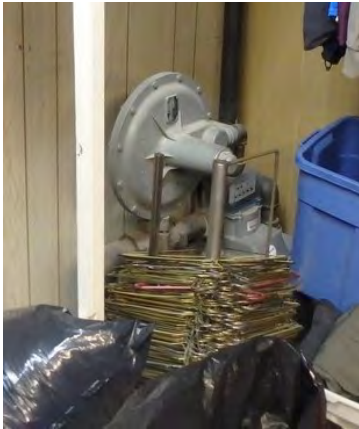
Onoway Curling Club - D301002

No significant deficiencies were observed or reported at the time of the field review. The component has exceeded its typical useful life, although its remaining useful life has been extended to a later year based on the absence of significant observed or reported deficiencies.

Recommendation #1 - Natural Gas Supply	
Type	Life Cycle Replacement
Year	2026
Cost	\$4,400.00

Replace Natural Gas Supply

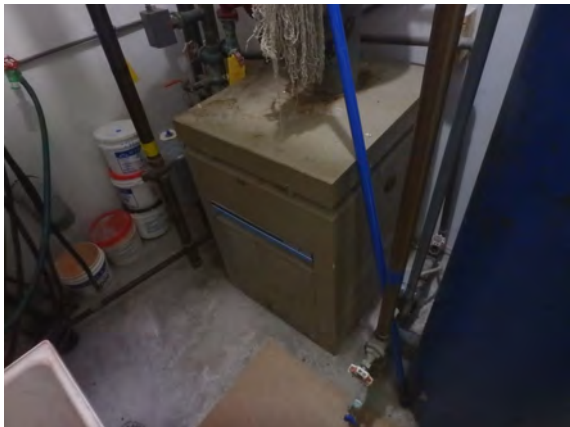
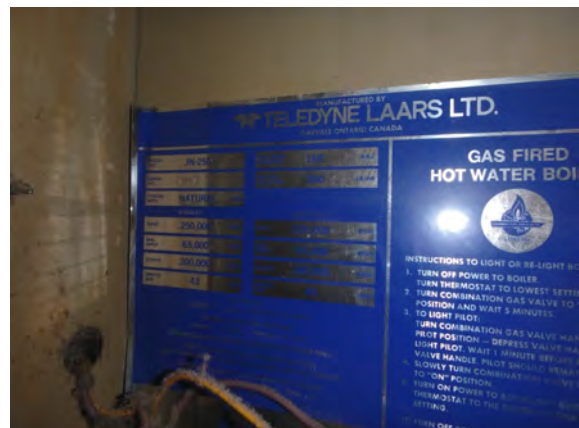
Onoway Curling Club - D302005

The component has surpassed its typical expected useful life and is showing signs of wearing consistent with its age. Based on the foregoing, the component is recommended for replacement in the early stages of the evaluation period.

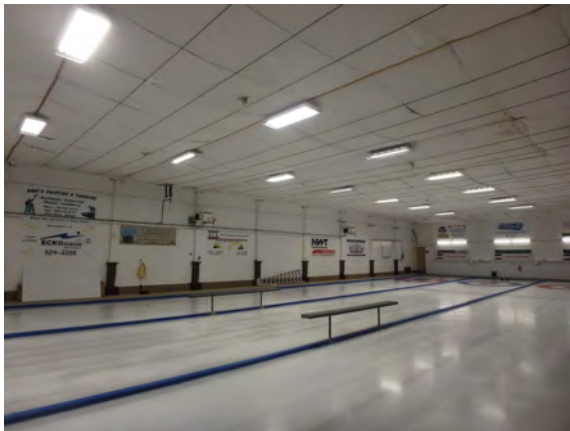
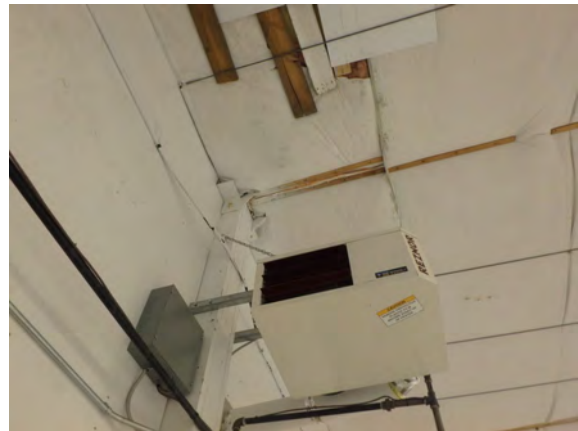
Onoway Curling Club - D302009

No significant deficiencies were observed or reported at the time of the field review.

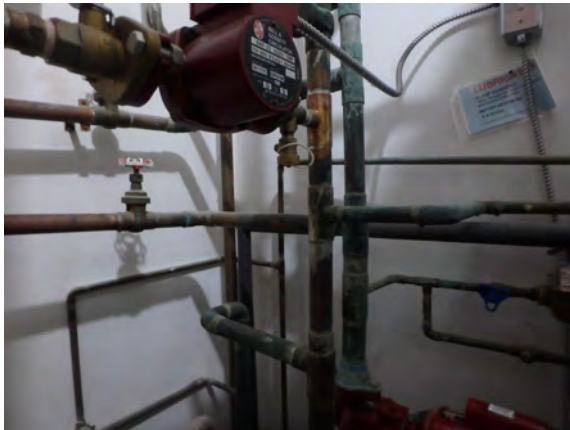
Onoway Curling Club - D304003

No significant deficiencies were observed or reported at the time of the field review. It should be noted that the review of the component was limited due to concealment by interior finishes.

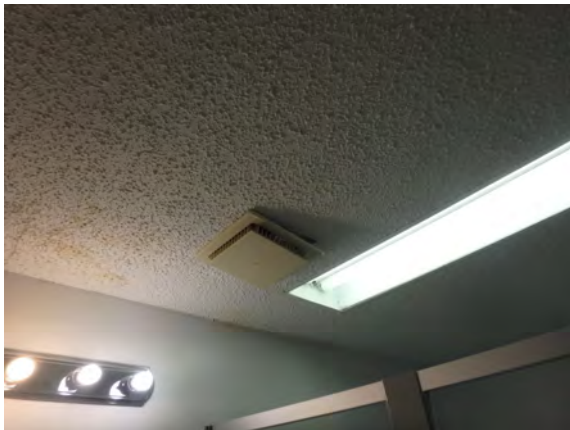
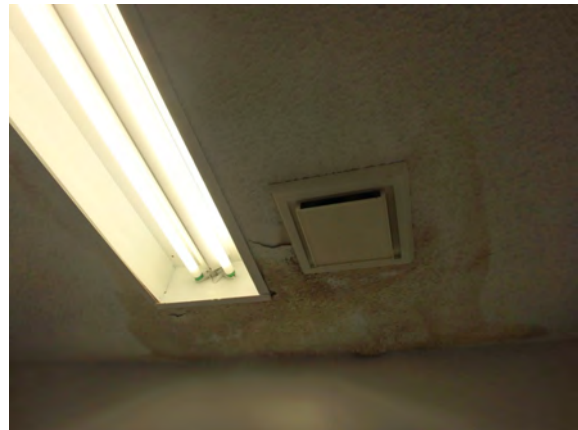
Onoway Curling Club - D304008

No significant deficiencies were observed or reported at the time of the field review.

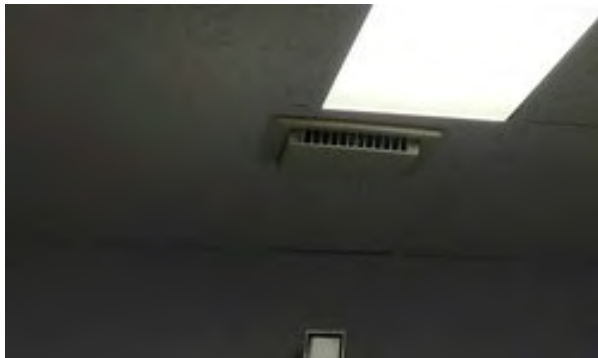
Onoway Curling Club - D304008

No significant deficiencies were observed or reported at the time of the field review.

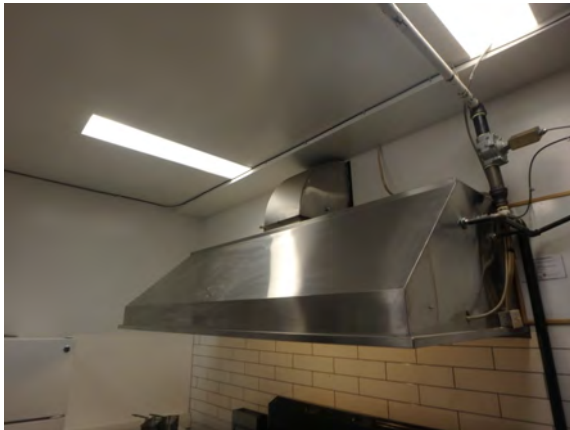
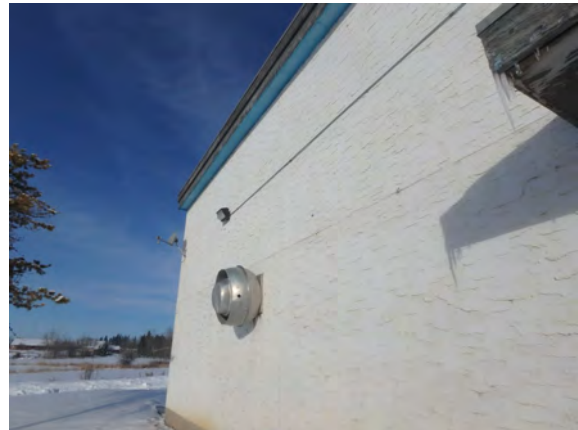
Onoway Curling Club - D304026

No significant deficiencies were observed or reported at the time of the field review. The range hood is recommended to be serviced annually by a qualified service contractor

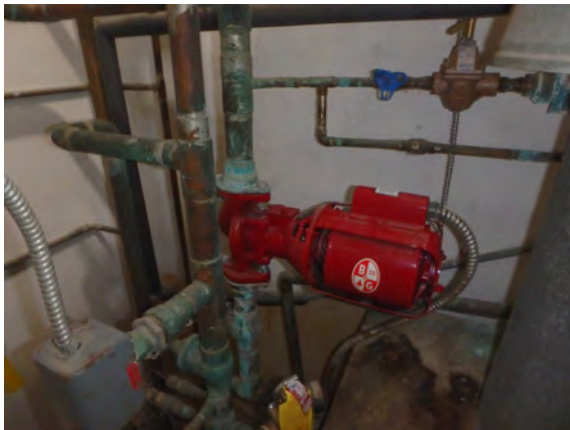
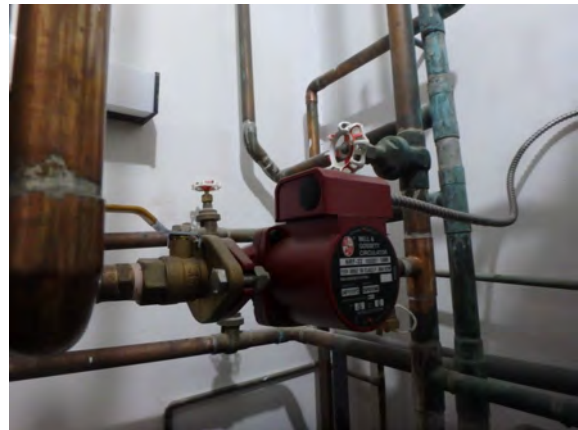
Onoway Curling Club - D304029

No significant deficiencies were observed or reported at the time of the field review.

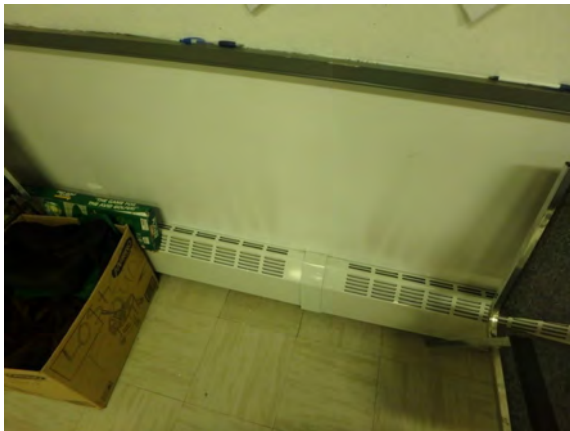
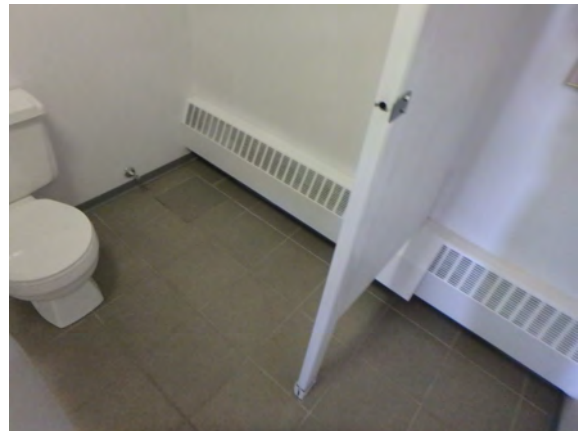
Onoway Curling Club - D305005

No significant deficiencies were observed or reported at the time of the field review therefore replacement has been deferred.

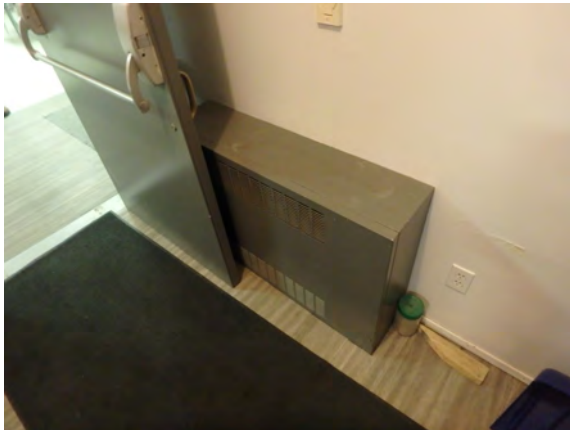
Onoway Curling Club - D305006

No significant deficiencies were observed or reported at the time of the field review therefore replacement has been deferred.

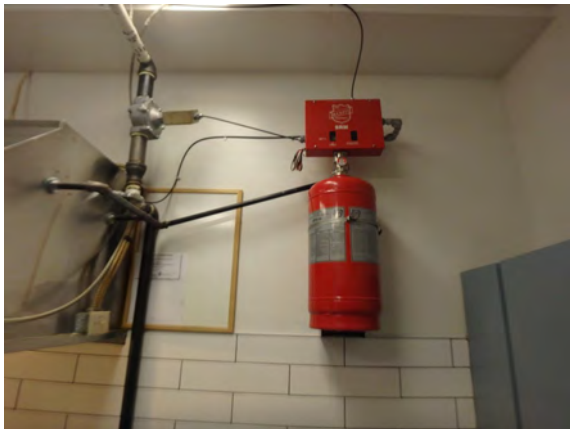
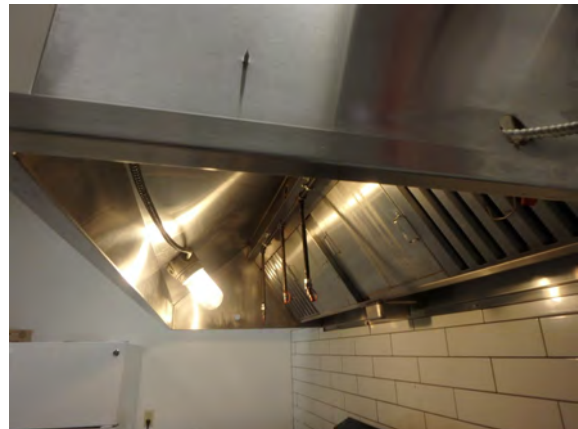
Onoway Curling Club - D409021

No significant deficiencies were observed or reported at the time of the field review. The fire suppression system is recommended to be serviced annually by a qualified service contractor.

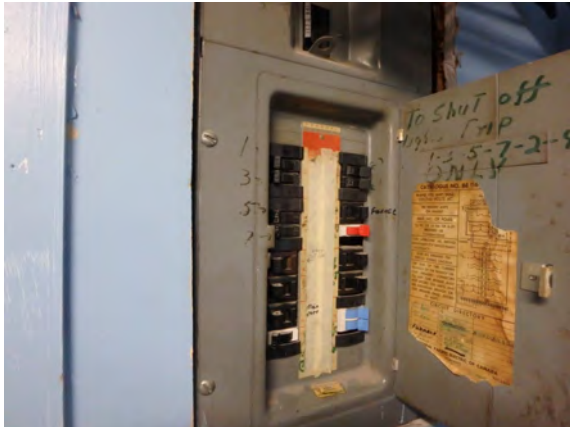
Onoway Curling Club - D501023

The component has surpassed its typical expected useful life and is showing signs of wearing consistent with its age. Based on the foregoing, the component is recommended for replacement in the early stages of the evaluation period.
