Property Condition Assessment Report – Onoway Curling Club

Version:Final

March 2020

Prepared by
FCAPX Ltd.
Project No. 19064

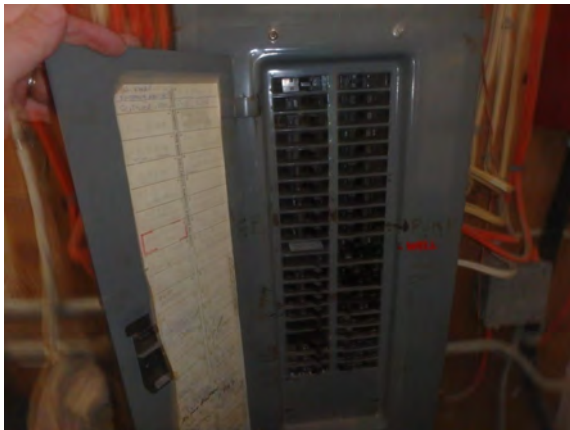
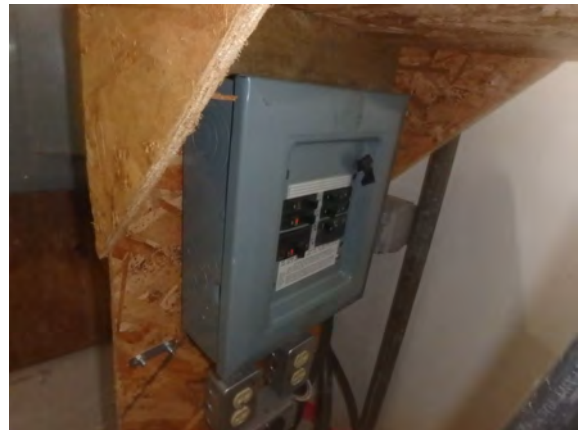
Onoway Curling Club - D501023

The electrical panel was installed in 2018. No major deficiencies were observed or reported.

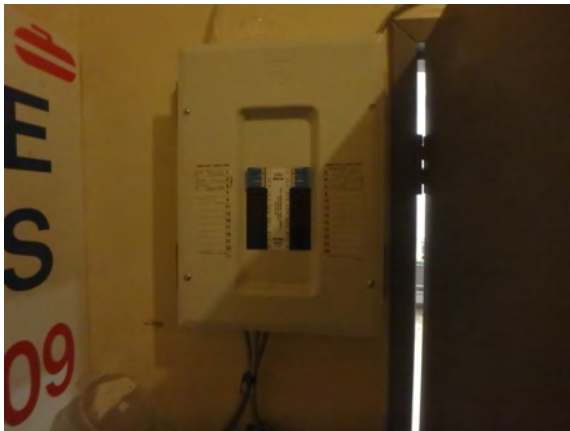
Onoway Curling Club - D501023

No significant deficiencies were observed or reported at the time of the field review.

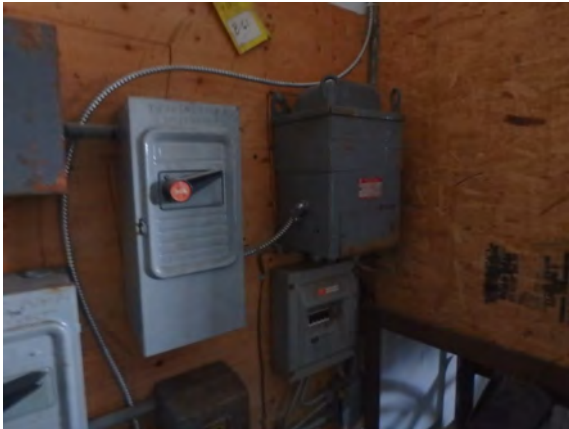
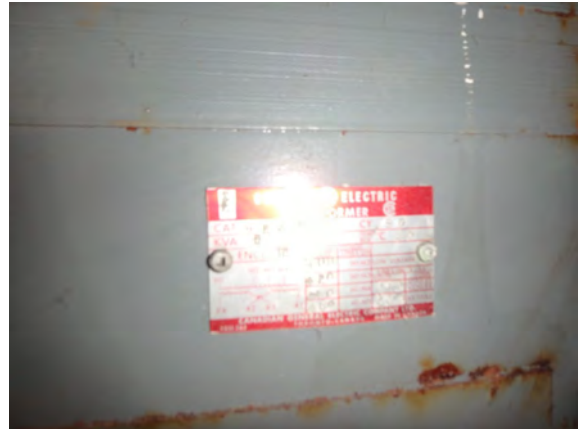
Onoway Curling Club - D501026

The component has surpassed its typical expected useful life and is showing signs of wearing consistent with its age. Based on the foregoing, the component is recommended for replacement in the early stages of the evaluation period.

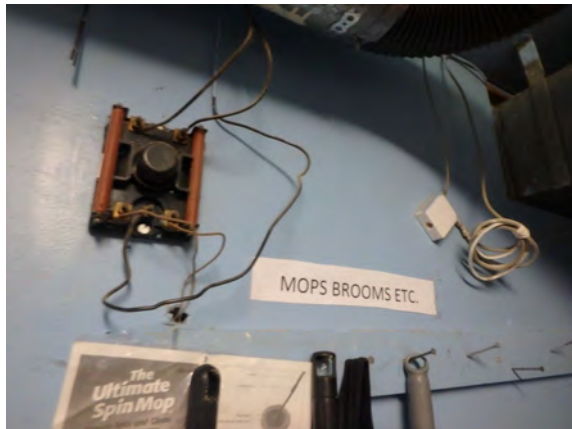
Onoway Curling Club - D502001

The component has surpassed its typical expected useful life and is showing signs of wearing consistent with its age. Based on the foregoing, the component is recommended for replacement in the early stages of the evaluation period.

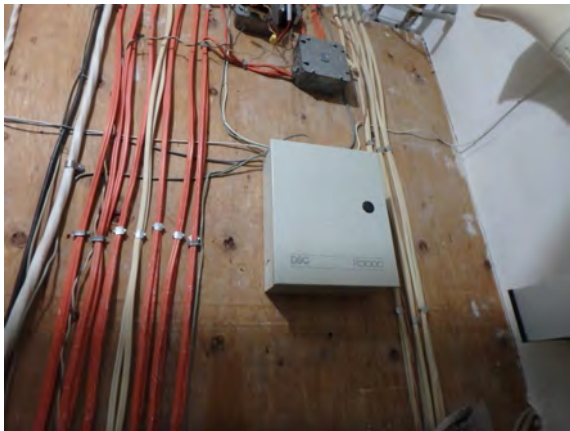
Onoway Curling Club - D502001

The component has surpassed its typical expected useful life and is showing signs of wearing consistent with its age.

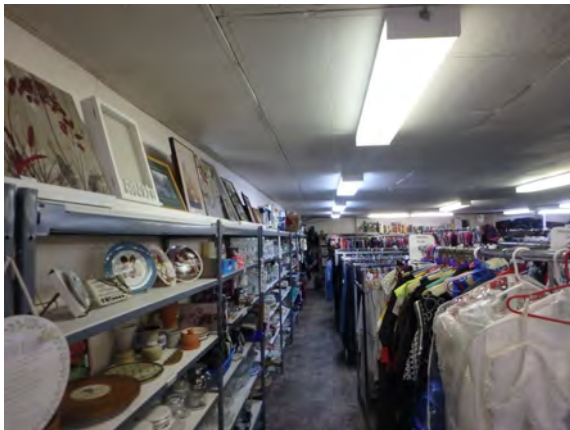
Onoway Curling Club - D502002

No significant deficiencies were observed or reported at the time of the field review.

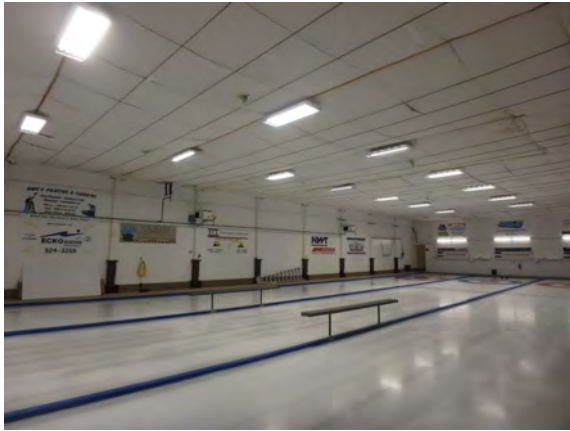
Onoway Curling Club - D502002

No significant deficiencies were observed or reported at the time of the field review.

Recommendation #1 - Interior Lighting	
Type	Life Cycle Replacement
Year	2045
Cost	\$62,475.00

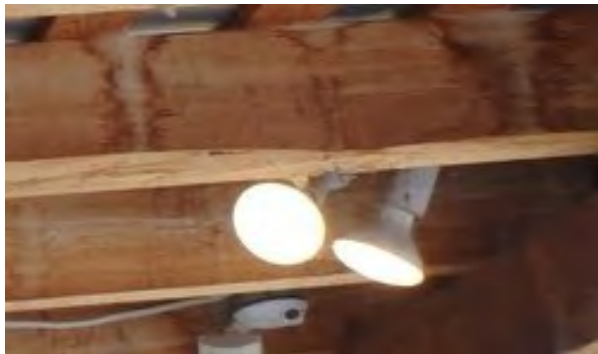
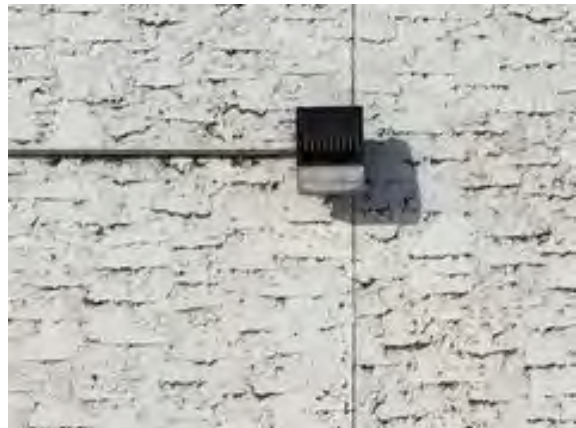
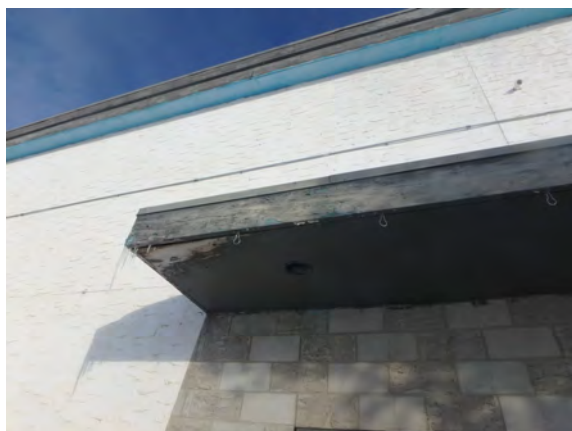
Onoway Curling Club - D502021

No significant deficiencies were observed or reported at the time of the field review.

Recommendation #1 - Exterior Lighting	
Type	Life Cycle Replacement
Year	2032
Cost	\$3,240.00

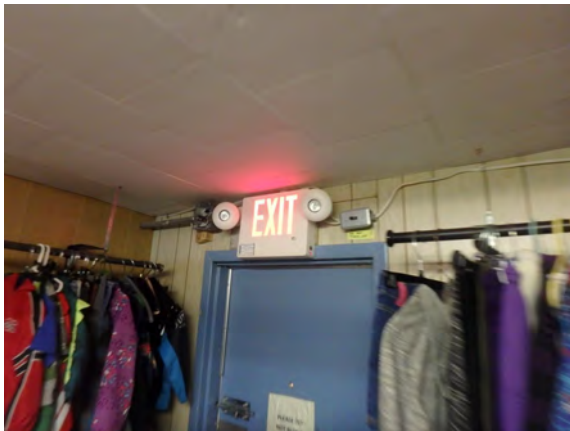
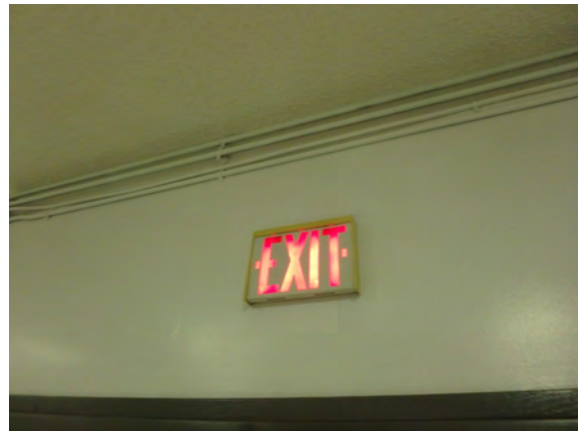
Onoway Curling Club - D502022

No significant deficiencies were observed or reported at the time of the field review; however it should be noted that the signage does not display the "green running man" illustration as per current regulations. Upgrading the light fixtures to incorporate modern illustration should be performed during future renewal activities.

Recommendation #1 - Exit Lighting	
Type	Life Cycle Replacement
Year	2025
Cost	\$4,125.00

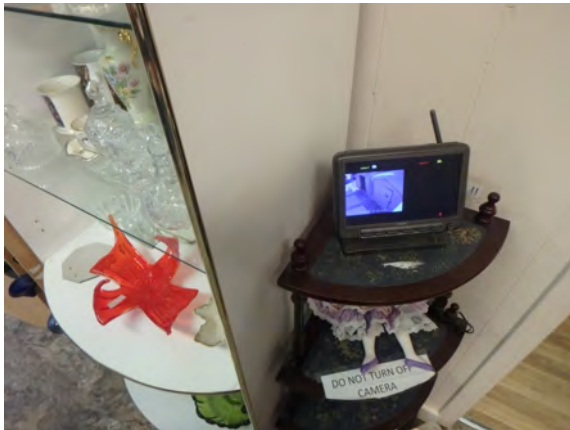
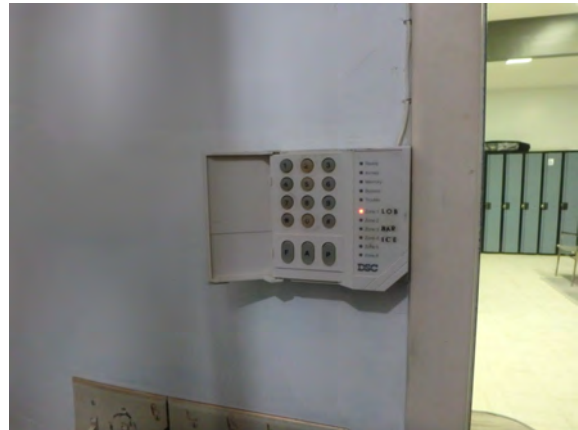
Onoway Curling Club - D503008

No significant deficiencies were observed or reported at the time of the field review.

Recommendation #1 - Security and Detection Systems	
Type	Life Cycle Replacement
Year	2032
Cost	\$13,750.00

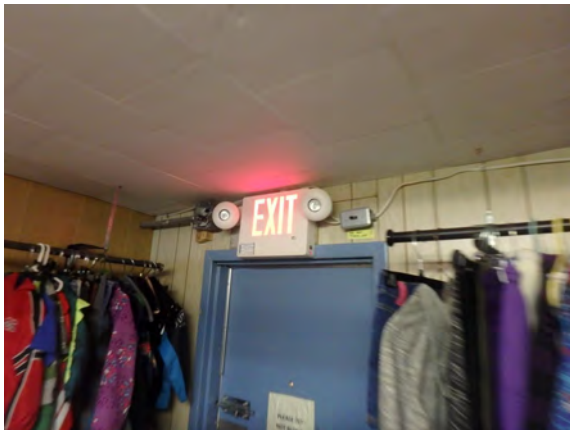
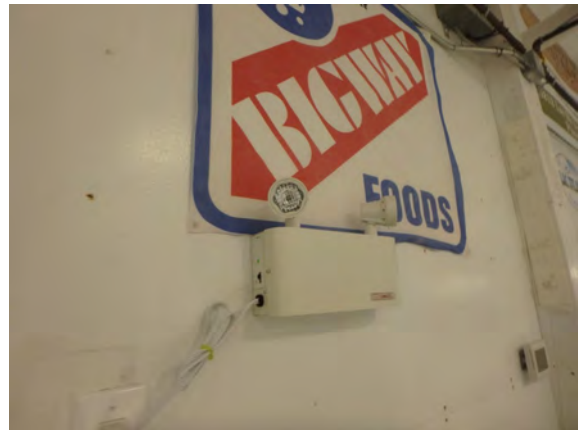
Onoway Curling Club - D509003

No significant deficiencies were observed or reported at the time of the field review.

Recommendation #1 - Emergency Lighting Systems	
Type	Life Cycle Replacement
Year	2032
Cost	\$6,875.00

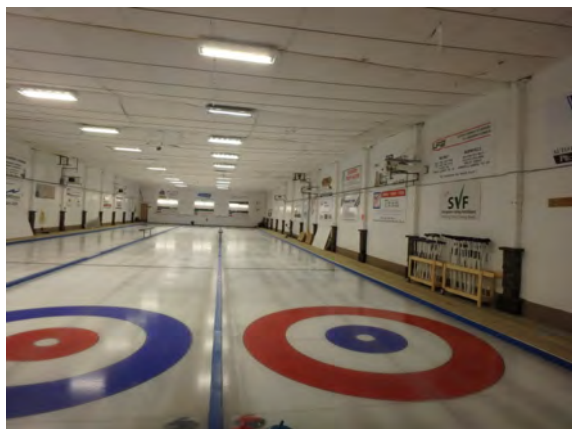
Onoway Curling Club - F104101

No significant deficiencies were observed or reported at the time of the field review. It should be noted that the review of the component was limited due to concealment by the ice surface.

Recommendation #1 - Ice Rink - Piping (No Slab)	
Type	Life Cycle Replacement
Year	2032
Cost	\$88,200.00

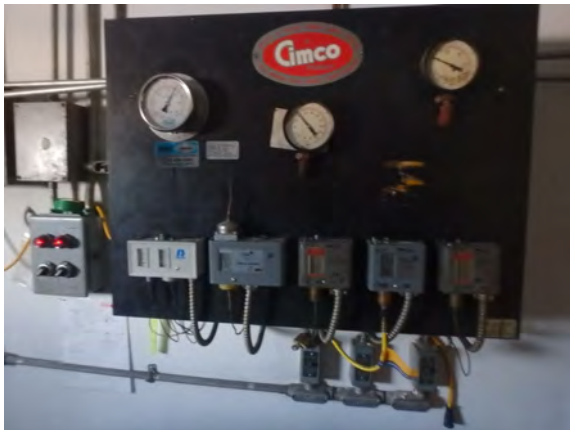
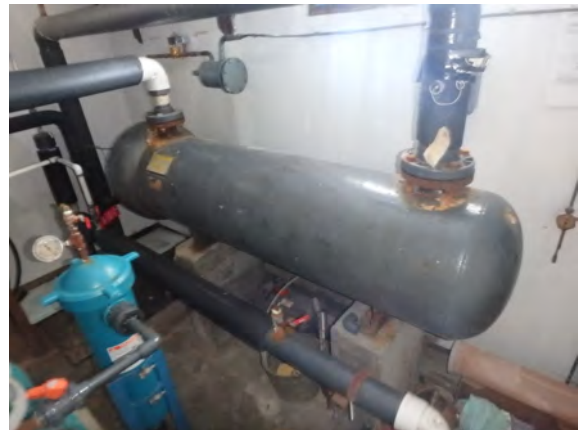
Onoway Curling Club - F104201

The component has surpassed its typical expected useful life and is showing signs of wearing consistent with its age. Based on the foregoing, the component is recommended for replacement in the early stages of the evaluation period. As the system uses refrigerant R-22 it is recommended the ice plant be replaced and relocated. See Ice rink condenser for more information.

Recommendation #1 - Ice Rink Chiller	
Type	Life Cycle Replacement
Year	2020
Cost	\$100,000.00

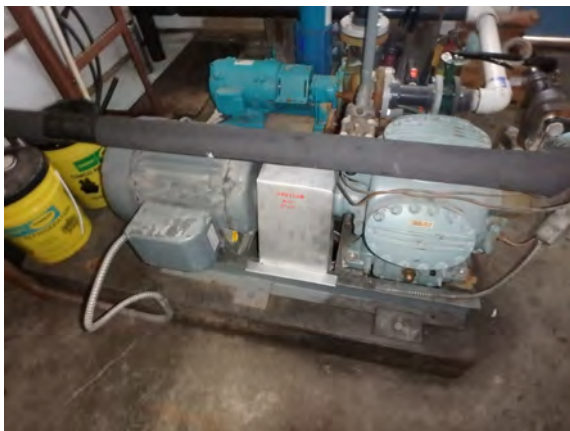
Onoway Curling Club - F104202

The component has surpassed its typical expected useful life and is showing signs of wearing consistent with its age. Based on the foregoing, the component is recommended for replacement in the early stages of the evaluation period. As the plant uses refrigerant R-22 it is recommended the plant be replaced and relocated.

Recommendation #1 - Ice Rink Compressors	
Type	Life Cycle Replacement
Year	2020
Cost	\$60,000.00

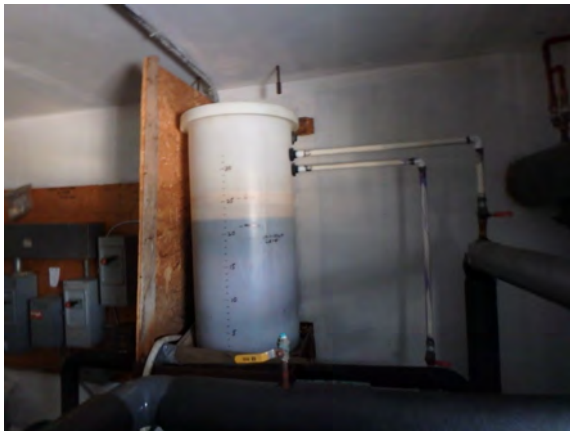
Onoway Curling Club - F104205

The component has surpassed its typical expected useful life and is showing signs of wearing consistent with its age. Based on the foregoing, the component is recommended for replacement in the early stages of the evaluation period.

Recommendation #1 - Ice Rink Storage Tanks	
Type	Life Cycle Replacement
Year	2020
Cost	\$2,000.00

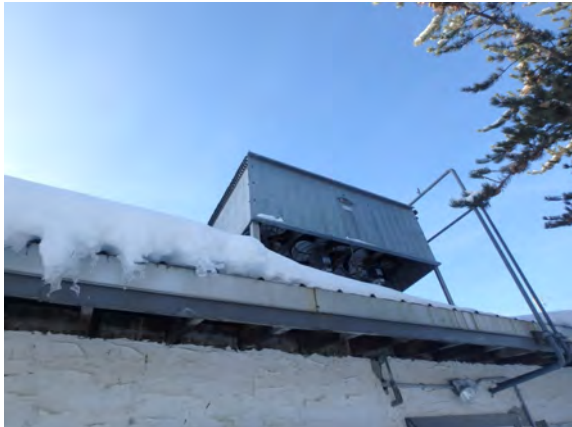
Onoway Curling Club - D303021

It was reported the unit has had refrigerant leaks. As the condenser utilizes refrigerant R-22 which is phased out as of 2020 meaning no more of this refrigerant is in production. In addition the plant distribution must run through the thrift shop to the curling rink. The plant should be replaced and relocated.

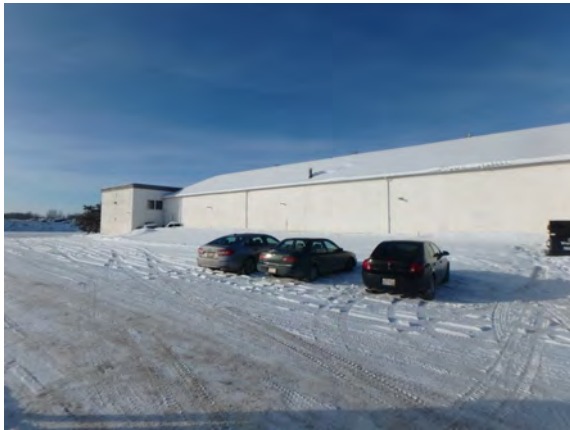
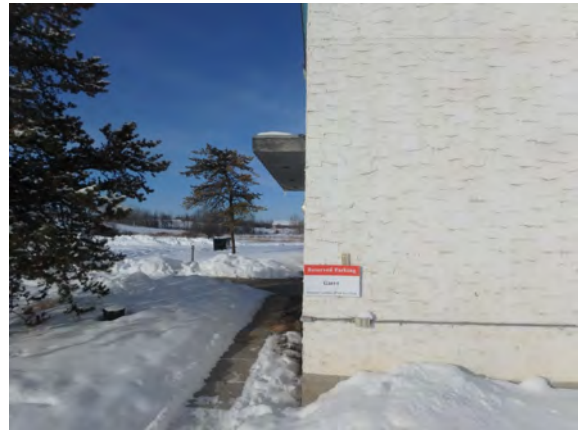
Onoway Curling Club - G202024

No significant deficiencies were observed or reported at the time of the field review. It should be noted that the review of the component was limited due to concealment by snow at the time of the assessment. The component has exceeded its typical useful life, although its remaining useful life has been extended to a later year based on the absence of significant observed or reported deficiencies.

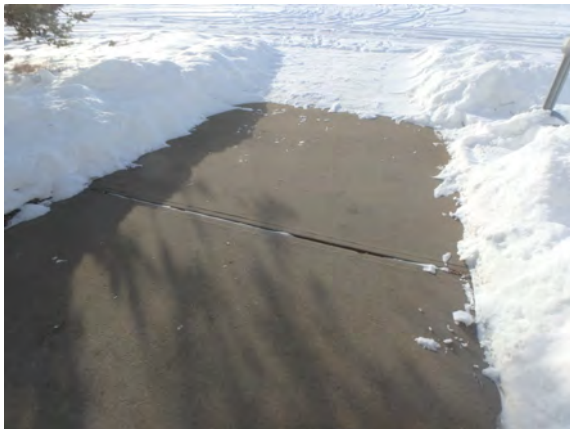
Onoway Curling Club - G203022

No significant deficiencies were observed or reported at the time of the field review. The component has exceeded its typical useful life, although its remaining useful life has been extended to a later year based on the absence of significant observed or reported deficiencies.

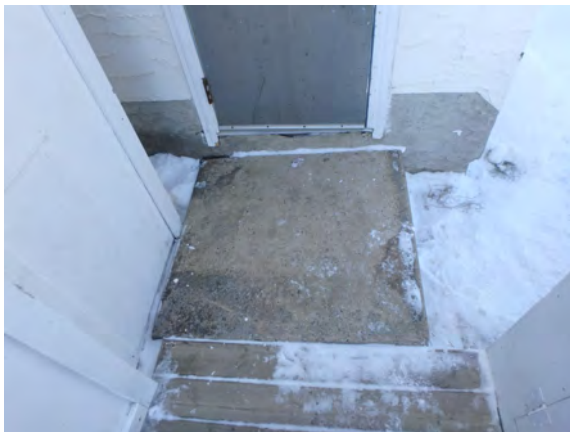
Onoway Curling Club - G203022

No significant deficiencies were observed or reported at the time of the field review. The component has exceeded its typical useful life, although its remaining useful life has been extended to a later year based on the absence of significant observed or reported deficiencies.

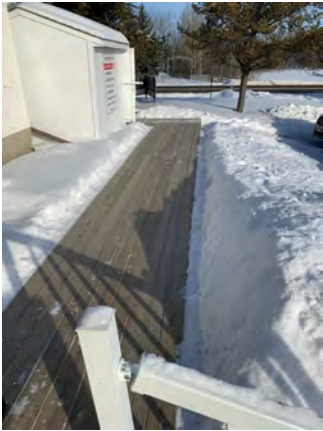
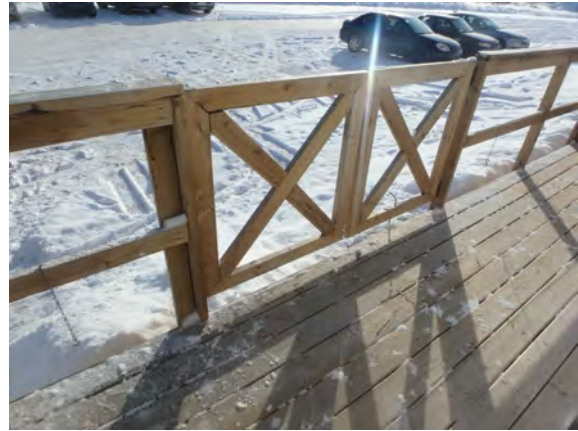
Onoway Curling Club - G203099

No significant deficiencies were observed or reported at the time of the field review.

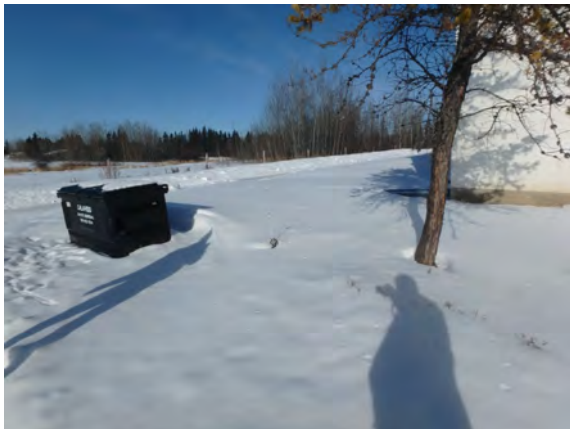
Onoway Curling Club - G3010

No significant deficiencies were observed or reported at the time of the field review. The component has exceeded its typical useful life, although its remaining useful life has been extended to a later year based on the absence of significant observed or reported deficiencies.

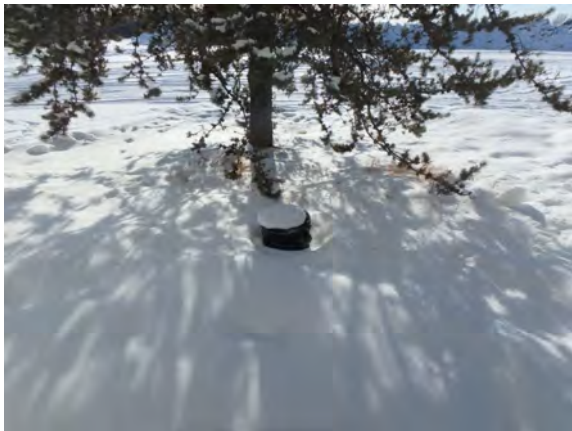
Onoway Curling Club - G3020

No significant deficiencies were observed or reported at the time of the field review.
