Town of Onoway Request for Decision

Meeting:	Council Meeting
Meeting Date:	November 24, 2022
Presented By:	Jennifer Thompson, Chief Administrative Officer Craig Rudderham, Public Works Foreman
Title:	Septage Receiving Station Update

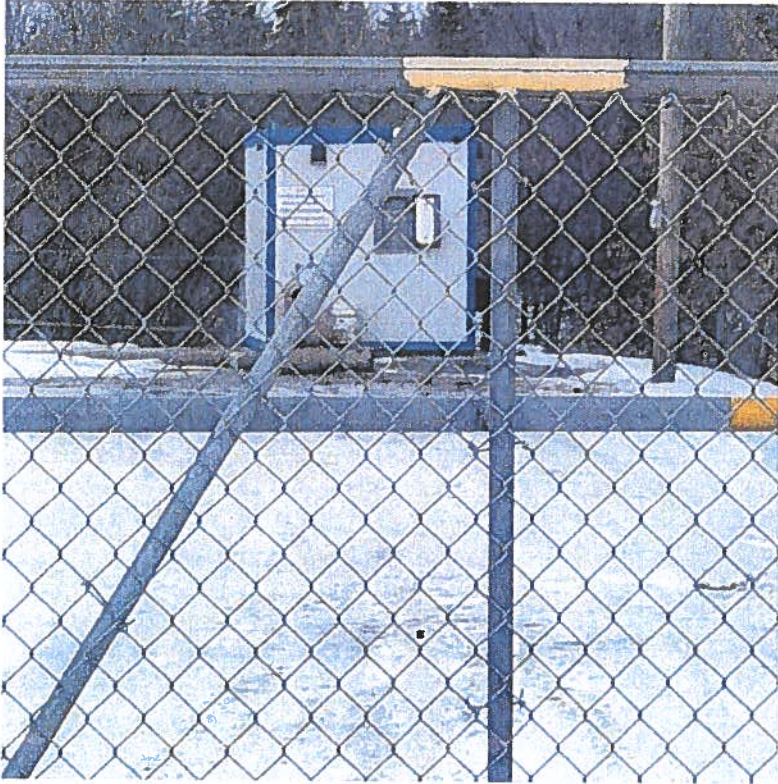
Villeneuve

Staff was onsite at locations where SRS are installed to observe the concerns. Staff were also onsite in other locations with different SRS machines installed.
